Report No. POL-005

**Executive Summary
Final Report: TU154M
101 Accident
Reconstruction**

2020-12-18

NIAR AVET Laboratories

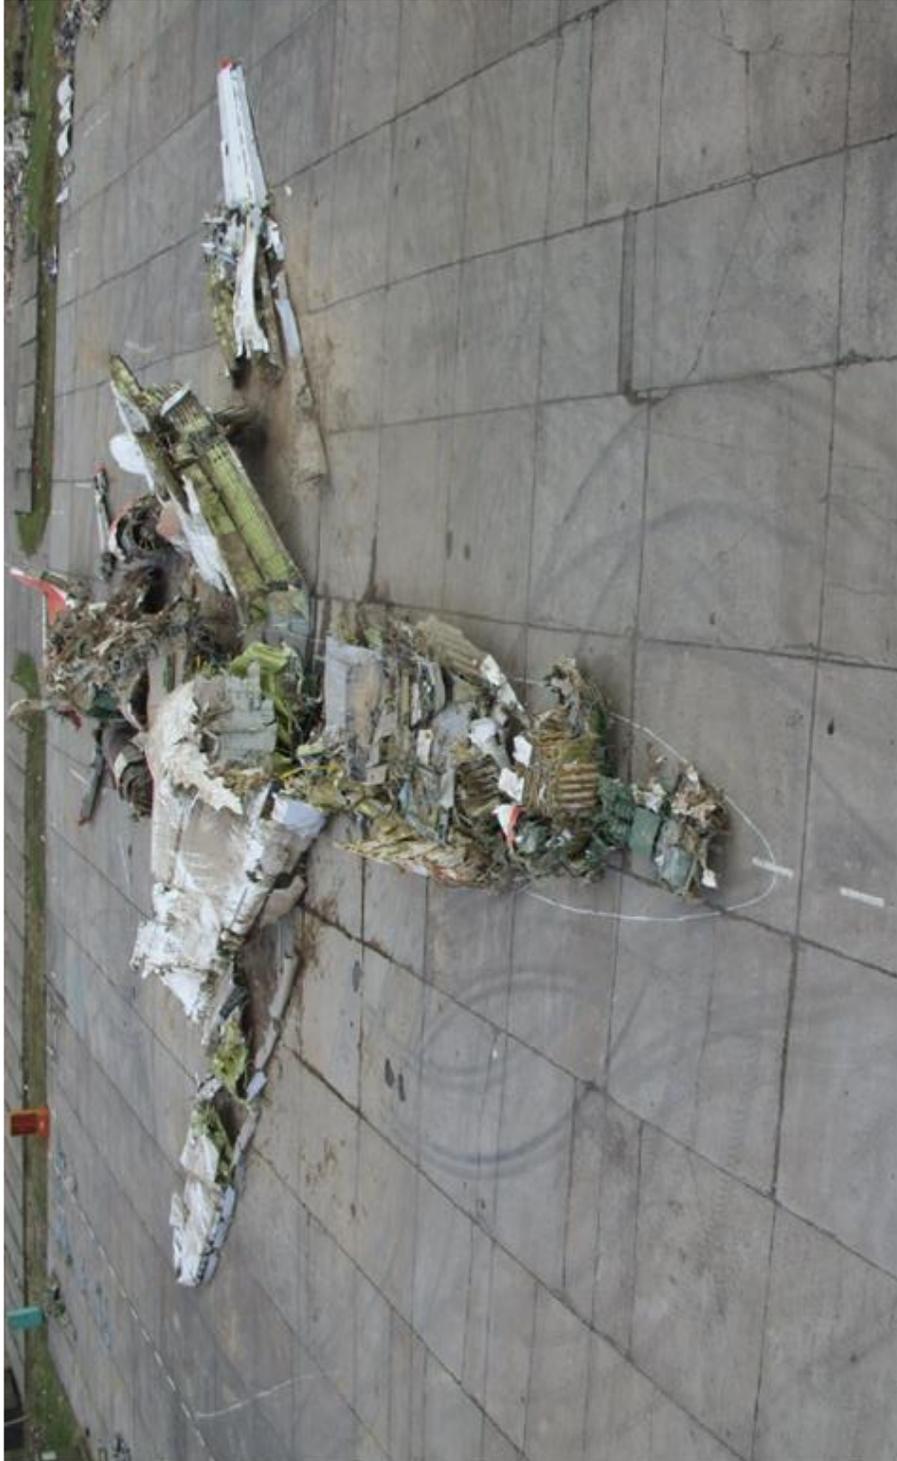
Major destruction of the aircraft was caused by the impact forces during the obstacle and ground collisions. The layout of damaged parts, shown in Figure 1.10, reveals that the aircraft was disintegrated into multiple pieces due to the impact with trees and ground.

Figure 1.10 Damage layout [1]

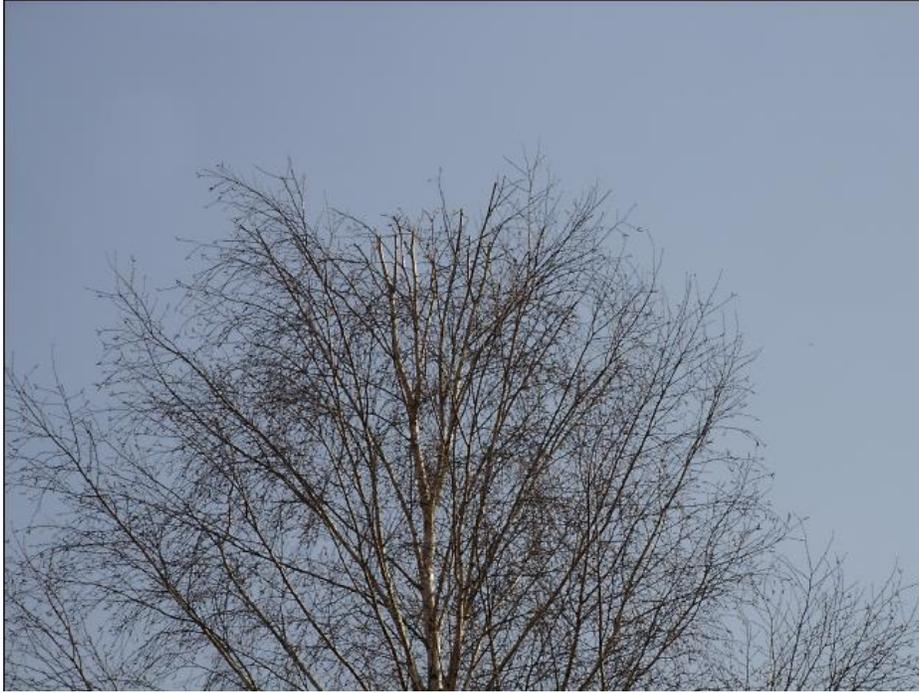
Sequentially, the first impact was with the top of a tree at the height of 11 m as shown in Figure 1.11. No parts of the aircraft were found at the first location. After the first impact and a distance of 244 m further with a lateral deviation of 61 m left from the centerline of the extended runway and at the height of about 5 meters, the aircraft wing hit a birch with a trunk of diameter measuring 30-40 cm (Figure 1.12). The investigation team found a left detachable part of the wing about 6.5 m long (Figure 1.13) at the area of impact. Followed by a hard left roll, and the aircraft further departed towards left. While rolling and moving further, the aircraft structure impacted with other trees and impacted the ground at a distance of 580 m from the first impact. The traces on the ground, shown in Figure 1.14, reveals that the impact occurred when aircraft was rolling towards left, and on impact, the aircraft was upturned with a left bank of about 200° - 210° [1].

Figure 1.11 Aircraft first impact on a tree top [1]

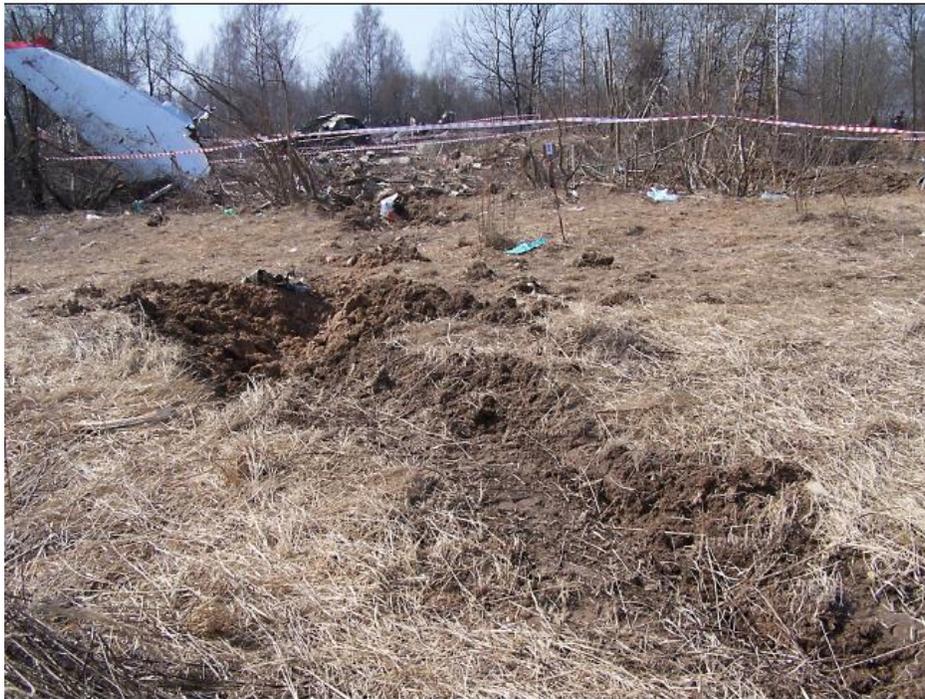
Figure 1.14 Traces of impact on ground [1]

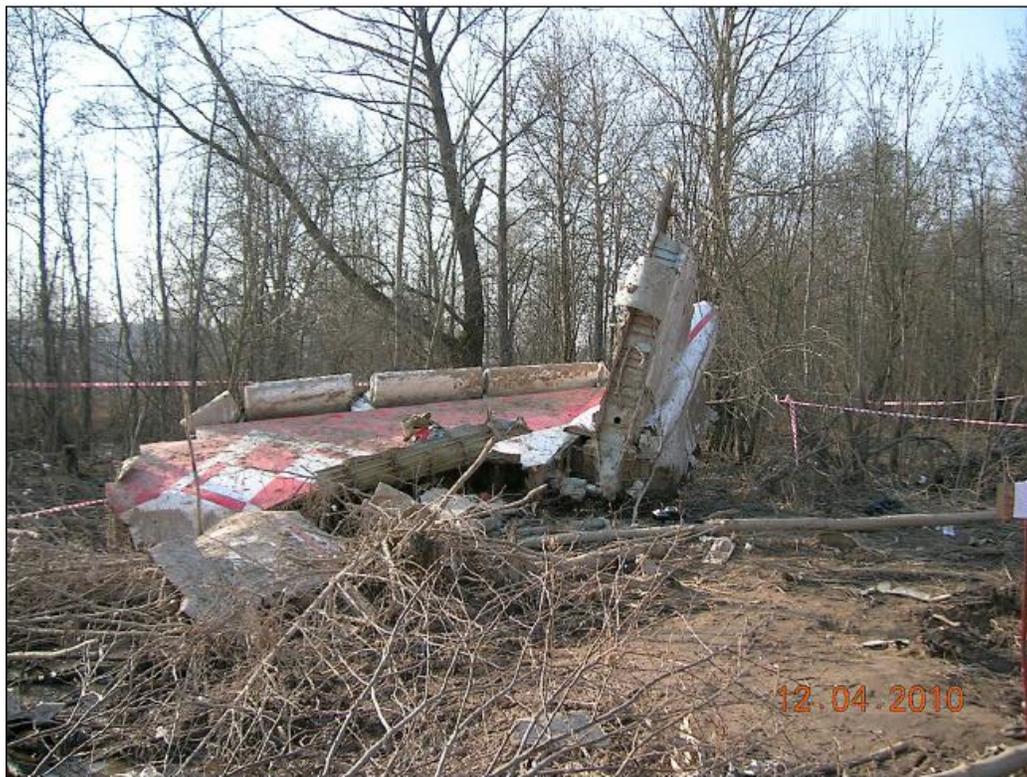
The right stabilizer panel with elevator, the fin, stabilizer, tail cone ripped off on impact. These parts were found at a distance of 590-620 m after the first impact (Figure 1.15).

Figure 1.15 Detached right stabilizer panel [1]

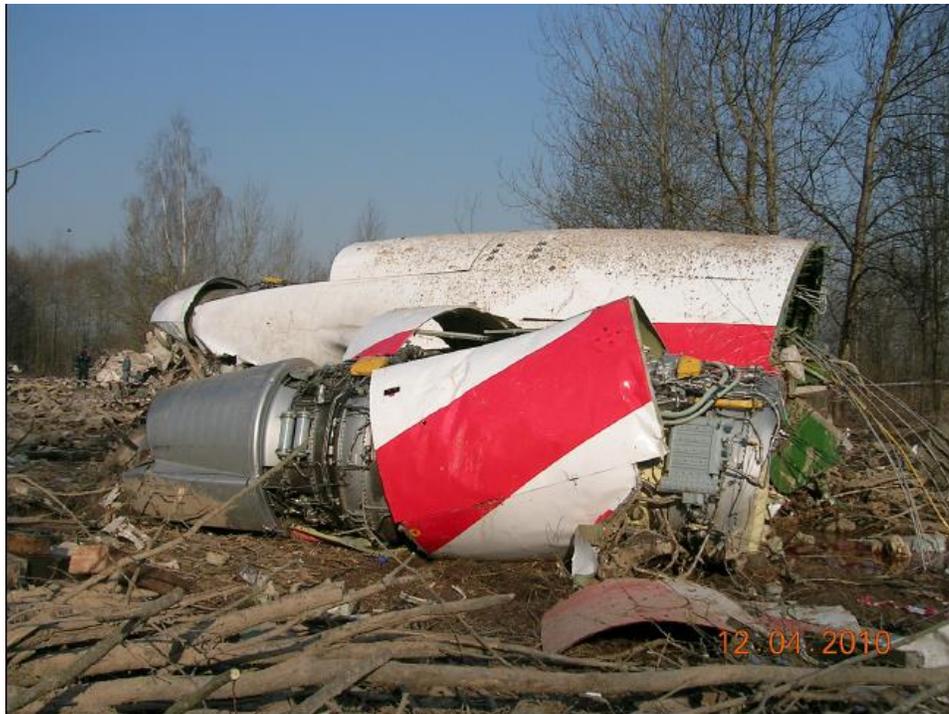
The aircraft was further damaged while moving upside down on the ground. The tail part of the aircraft with engines and other fragments is at a distance of 436 m from the runway threshold and turned 180 ° (Figure 1.17).

Figure 1.17 Damaged engine mount [1]

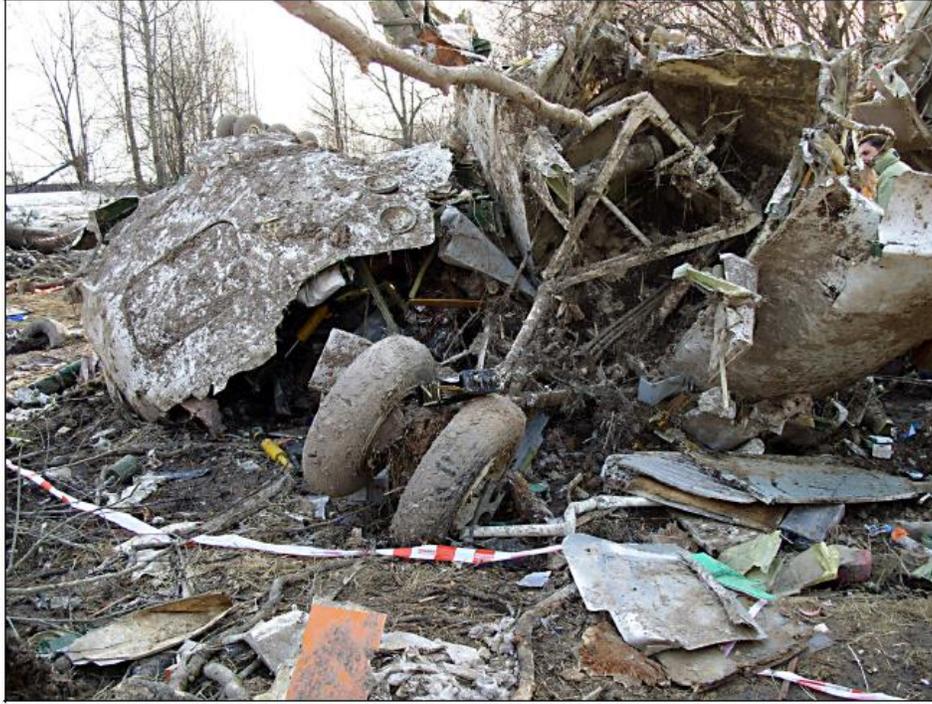
A part of the nose landing gear in an extended position is at a distance of 397 m from the runway threshold (Figure 1.18). Fragments of the aircraft revealed no signs of burning. Owing to unforeseen load factors, the aircraft got destroyed on contact with trees, land, and the ground surface during its further flight [1].

Figure 1.18 Nose landing gear [1]

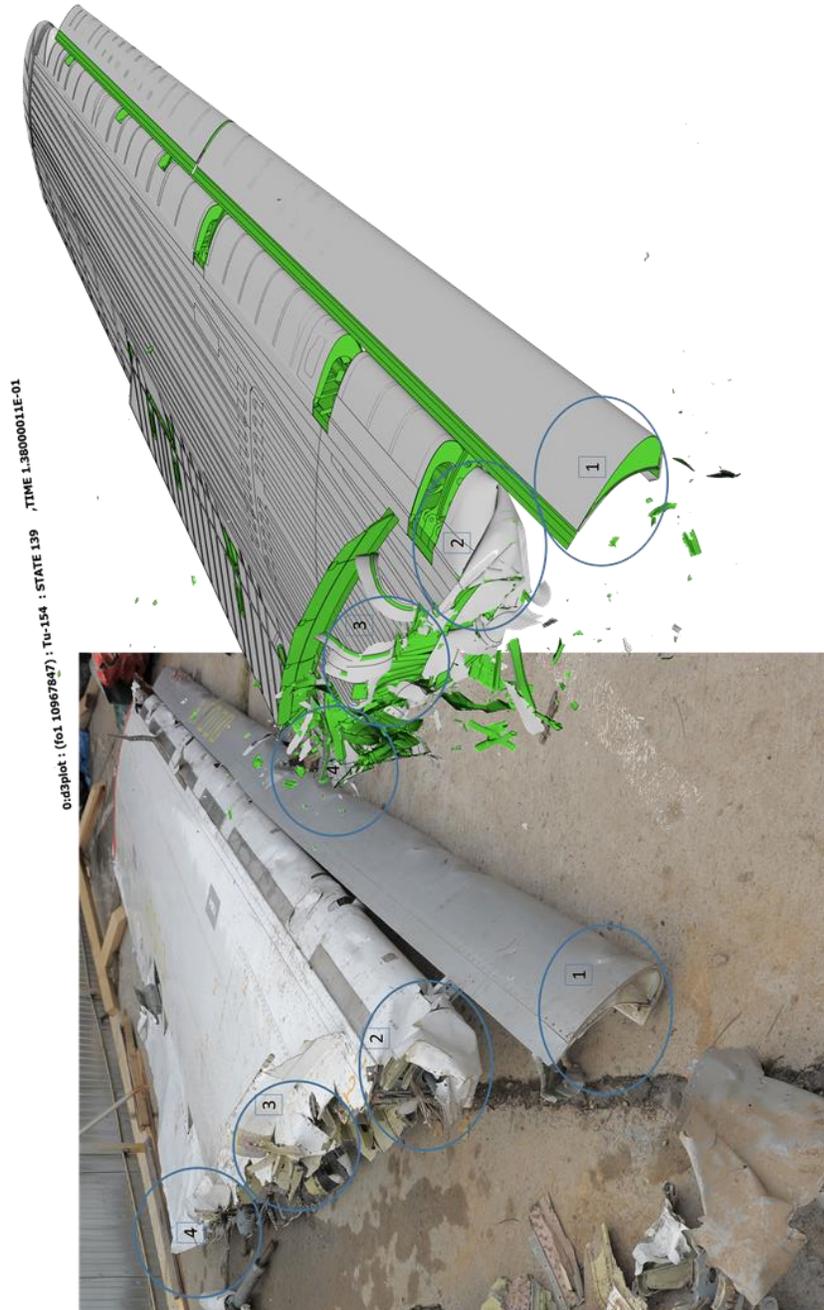
Figure 3.19 Separated wing damage comparison (138 ms) with debris image by the PSC [19]

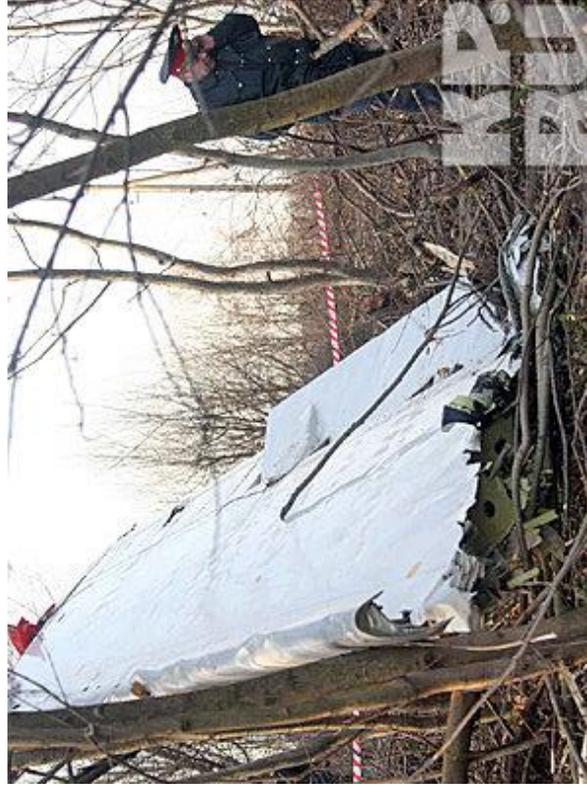
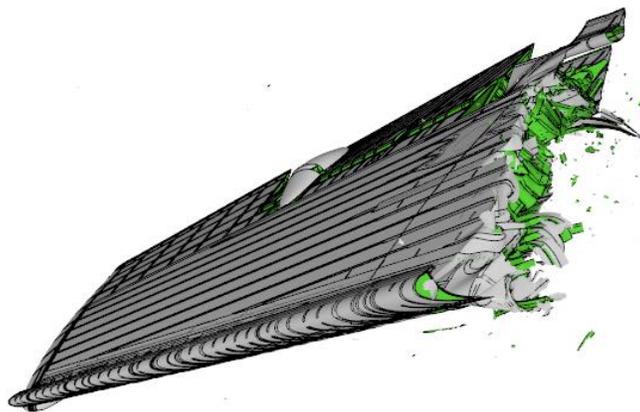
Figure 3.23 Separated wing damage comparison with debris image by the PSC [19]

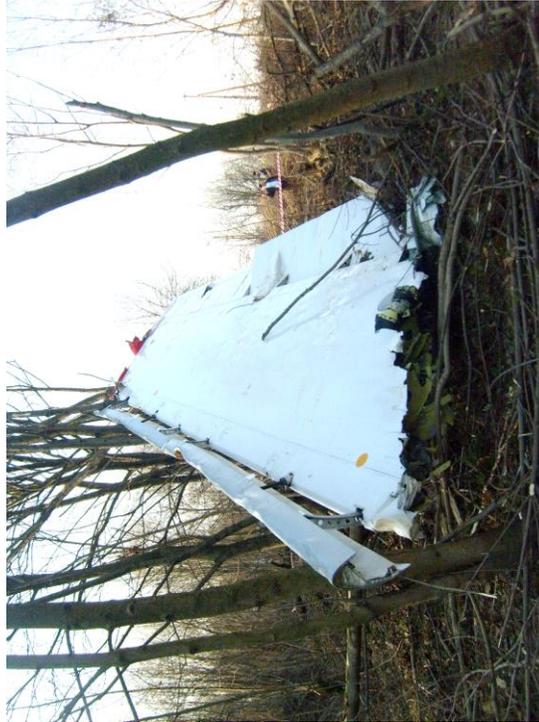
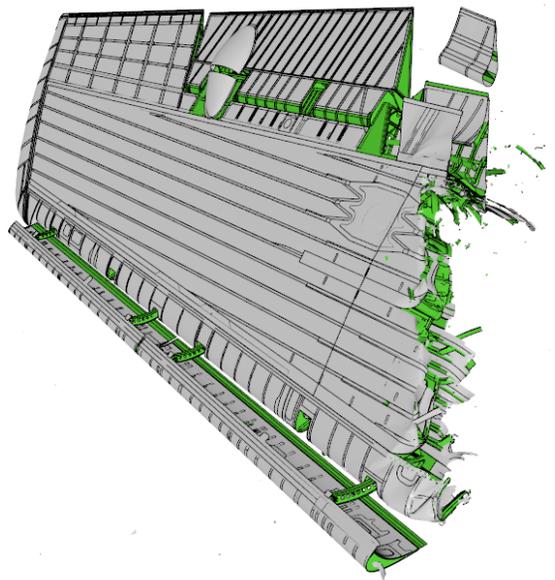
Figure 3.24 Separated wing damage comparison with debris image by the PSC [19]

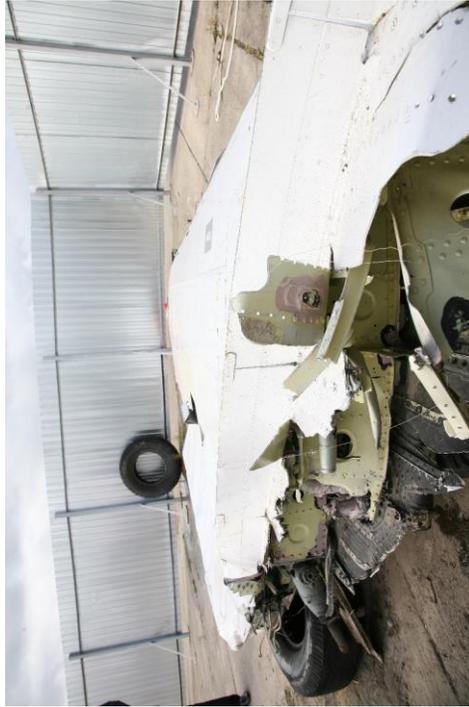
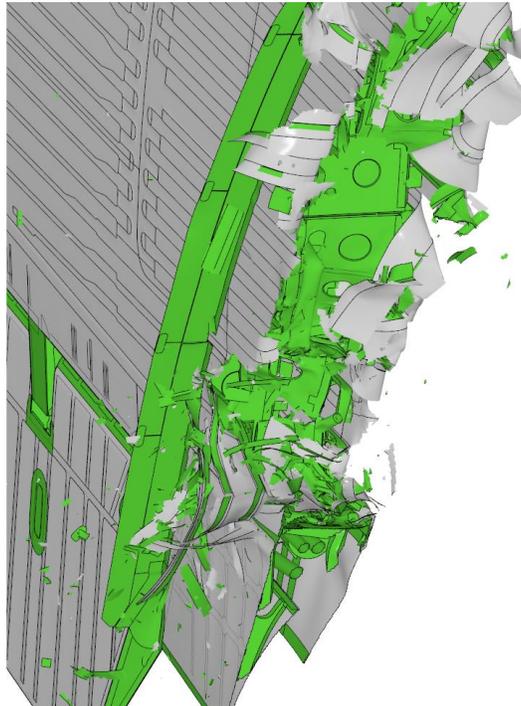
Figure 3.26 Separated wing damage comparison with debris image by the PSC [20]

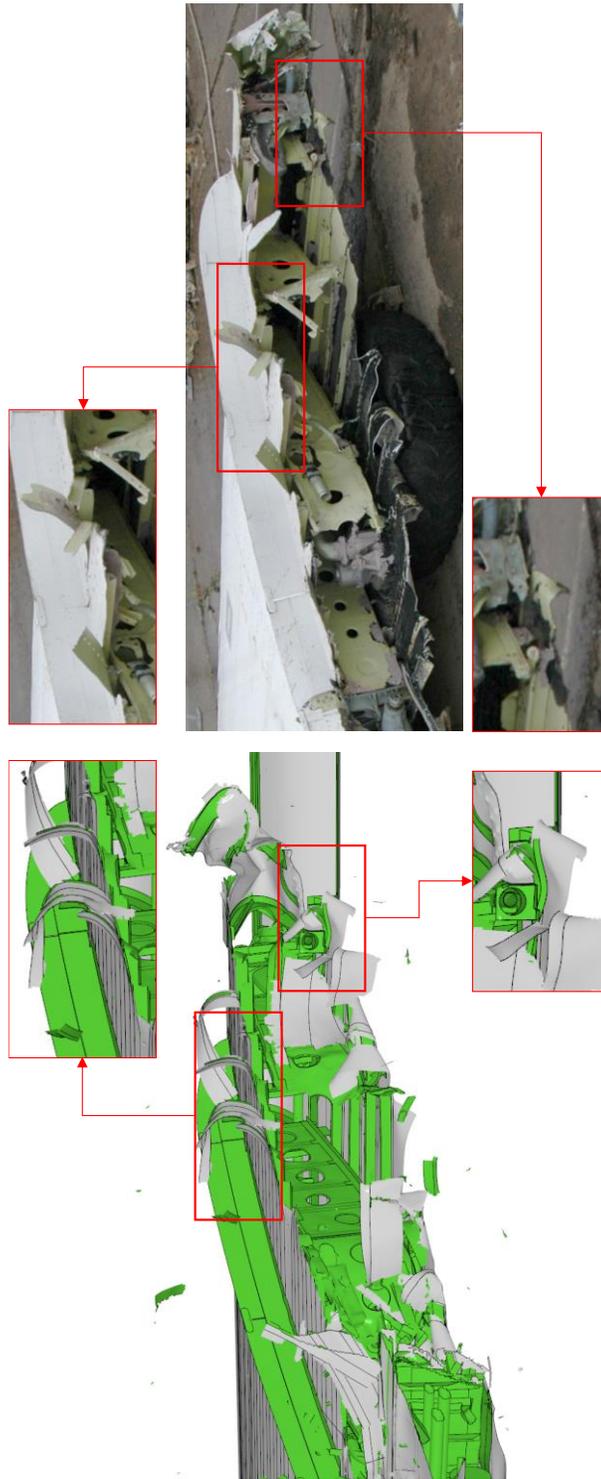
Figure 3.27 Separated wing damage comparison with debris image by the PSC [20]

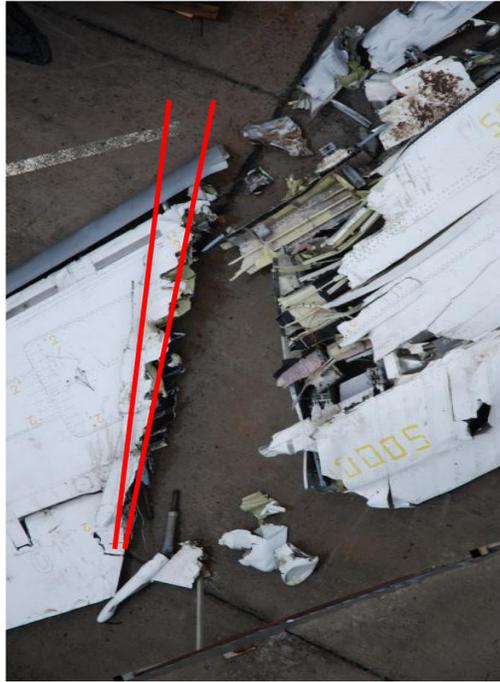
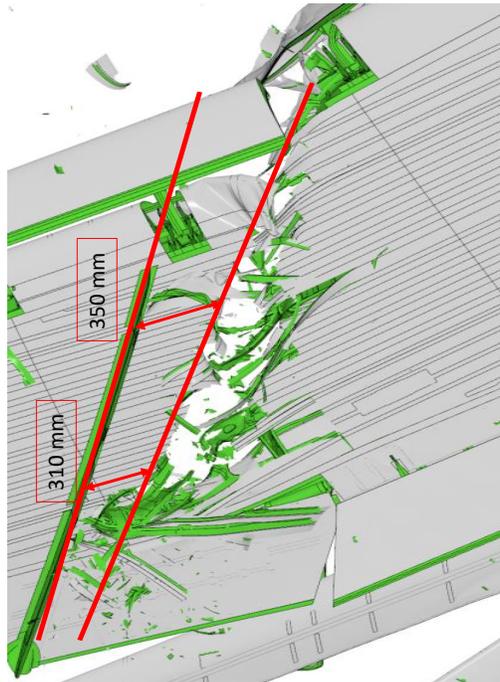
Figure 3.28 Separated wing damage comparison with debris image from the PSC [20]

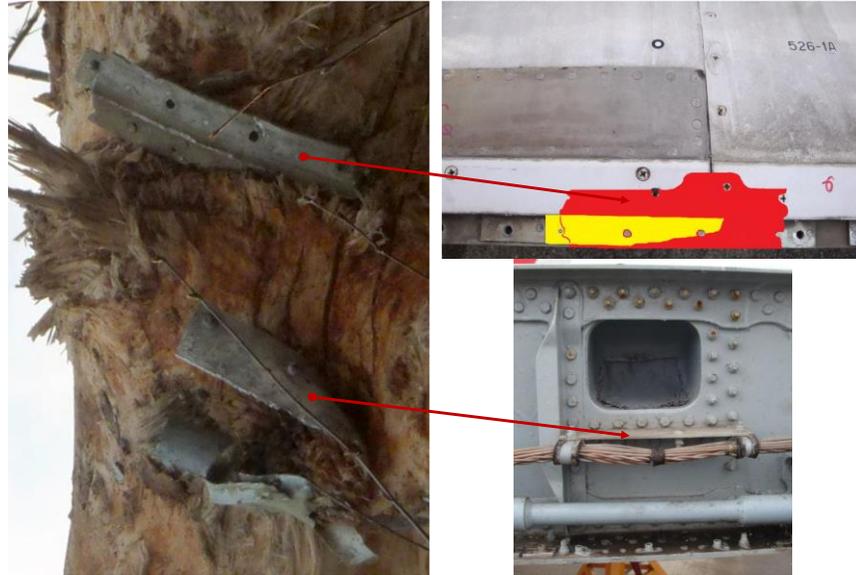
Figure 3.29 Fragments embedded in birch tree identified by the PSC [21]

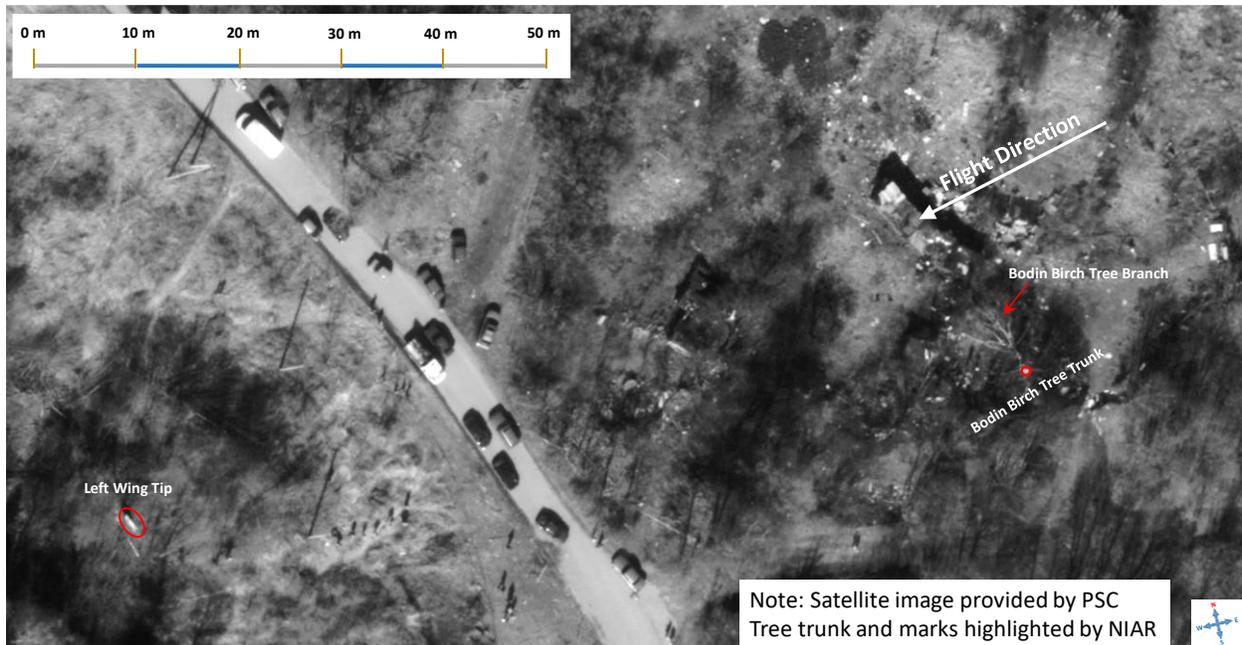
In the satellite image of the debris field [19][6], after impact with the wing, the top piece of the tree fell to the side towards the Bodin hut. From the aircraft flight path perspective, the top piece fell towards the right wing of the aircraft as shown in Figure 3.37. Since the wing tree impact reconstruction analysis was not run long enough to see the tree fall to ground, a trajectory analysis was performed by solving the six degrees-of-freedom (6DOF) equations of motion using Matlab Simulink.

Figure 3.37 Crash site satellite image close-up view of the Bodin birch tree [19]

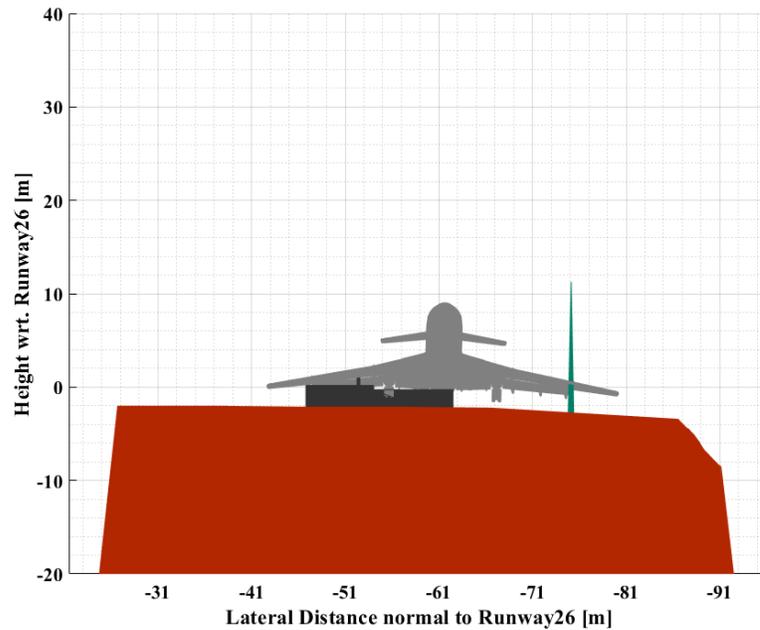
- According to the MAK report, page no. 75, the left wing of the aircraft impacted the Bodin birch tree at a height of 5 m above the ground. The height of 5 m is inconsistent with the findings of the prosecutor report [11], which claims the height to be 6.75 m. For the impact height of 5 m, the right main landing gear of the aircraft would impact with the Bodin hut as shown in Figure 3.41. This is confirmed by the photographs taken at the accident site where it is shown that the Bodin Hut was not impacted by the aircraft landing gear (see Figure 3.42). Detailed analysis is also shown in Annex II Trajectory analysis report [10].

Figure 3.41 NIAR trajectory analysis showing birch tree impact at 5 m height as per MAK report

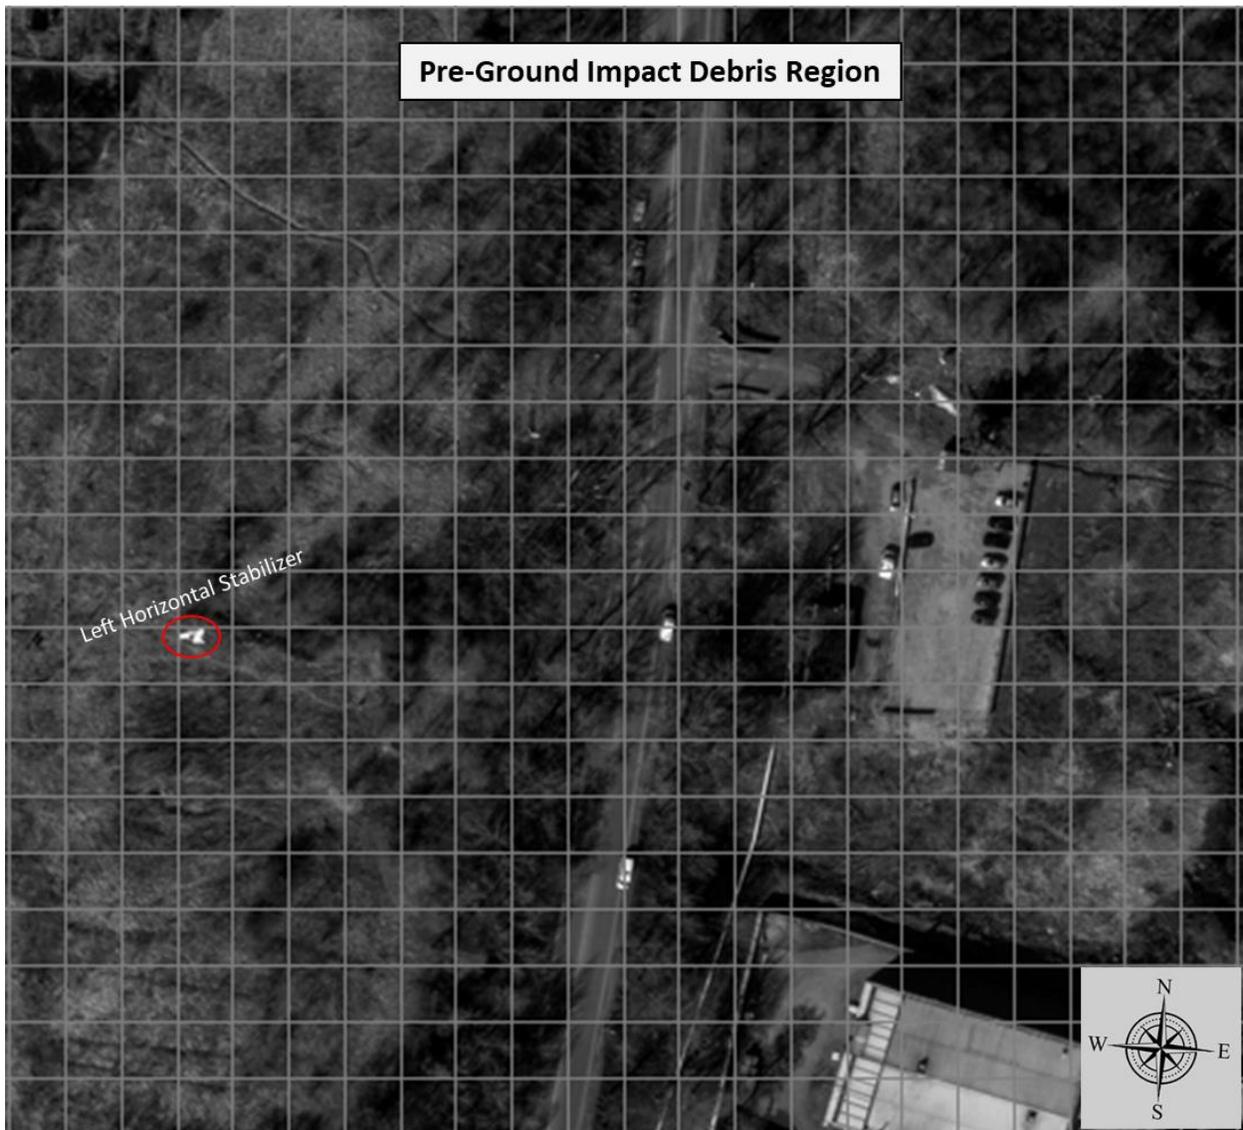
Figure 4.17 presents the satellite image of the pre-ground impact debris region on the 10th of April of 2010, specifying the location of the left horizontal stabilizer fragment. The grid overlaid on Figure 4.17 divides the image on areas of 10 x10 meters. Figure 4.18 shows the large debris located in this region, which corresponds to the left horizontal stabilizer.

Figure 4.17 Pre-ground impact debris region [6]

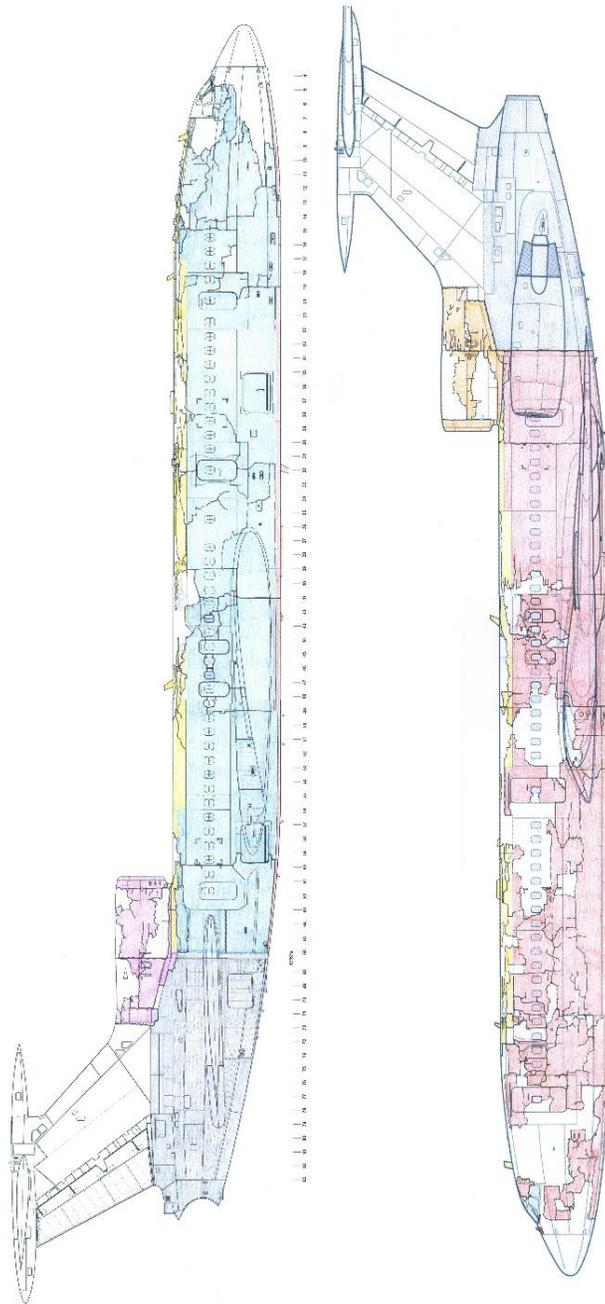
Figure 4.26 corresponds to the fragmentation sketch prepared by PSC based on all the fragments of the aircraft identified in the crash site. All size of fragments, small and large have been included in this drawing. The fracture lines indicate the areas the sustained high stresses during the crash, leading to their failure.

Figure 4.26 PSC aircraft debris fragmentation sketch [25]

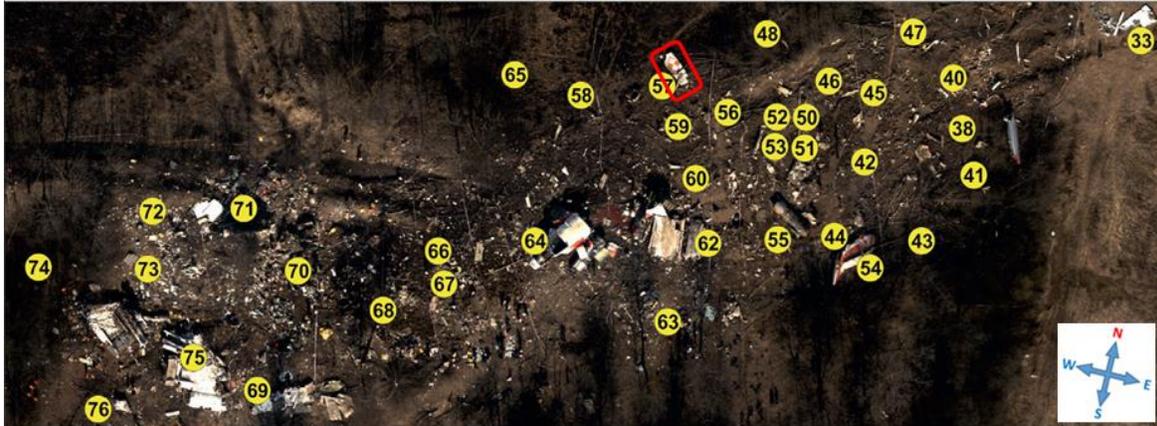
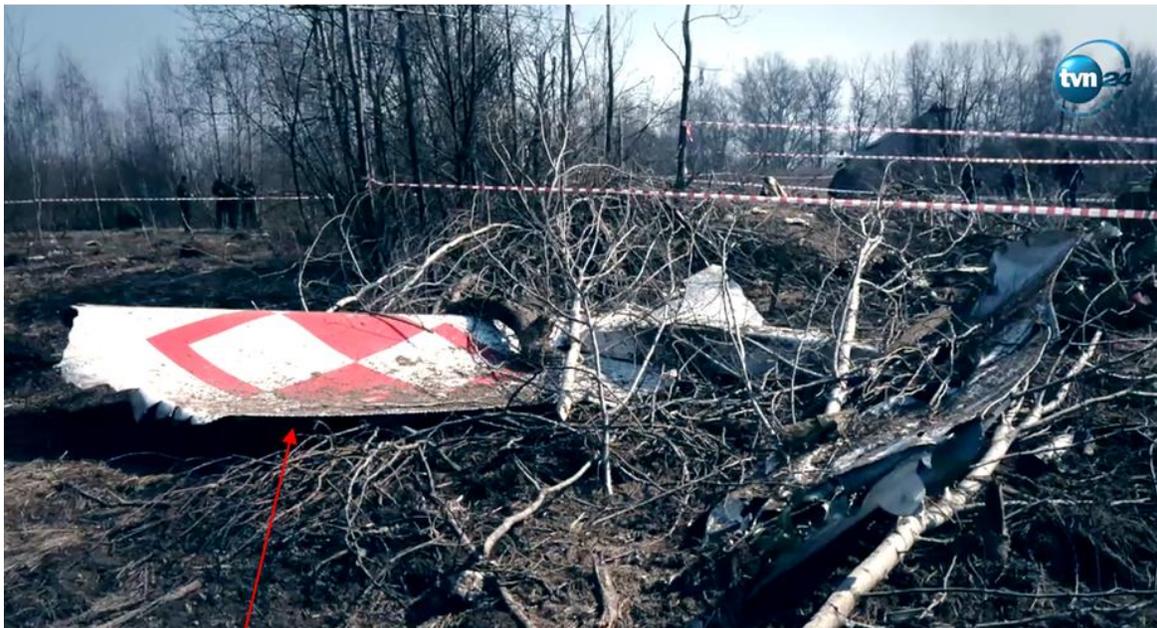
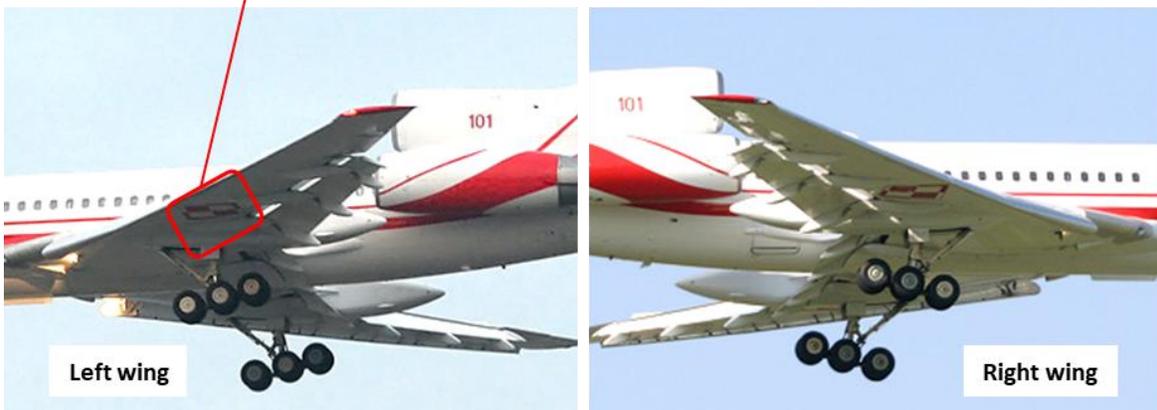
Other discrepancies identified between the official MAK report [1] and PSC images correspond to differences in fragments locations at the crash site. The satellite image provided by PSC (gray scale image) belongs to the 10th of April of 2010. This image presents the status of the debris field hours after the crash. MAK report wreckage section [1] did not include any indications of the date of the provided wreckage image. Figure 4.29 overlays the Northeast wreckage area the MAK image and the PSC satellite image.

Figure 4.28 Left outer-wing lower skin panel
