**STRESZCZENIA ZAWARTOŚCI ZDAŃ ODRĘBNYCH  
SPORZĄDZONYCH PRZEZ ZESPÓŁ LOTNICZO-NAWIGACYJNY**

Streszczenia „zdań odrębnych” przeprowadzono w oparciu o dokumentację Centralnego Archiwum Wojskowego. Dotyczyła ona problemów poruszanych przez Zespół Lotniczo-Nawigacyjny Podkomisji do ponownego badania wypadku lotniczego. Zespół ten odnosił się do zagadnień związanych z pracami NIAR, projektem LARE, badaniami dotyczącymi materiałów wybuchowych oraz do innych zagadnień. Poniżej zestawiono informacje zawarte w tej dokumentacji.

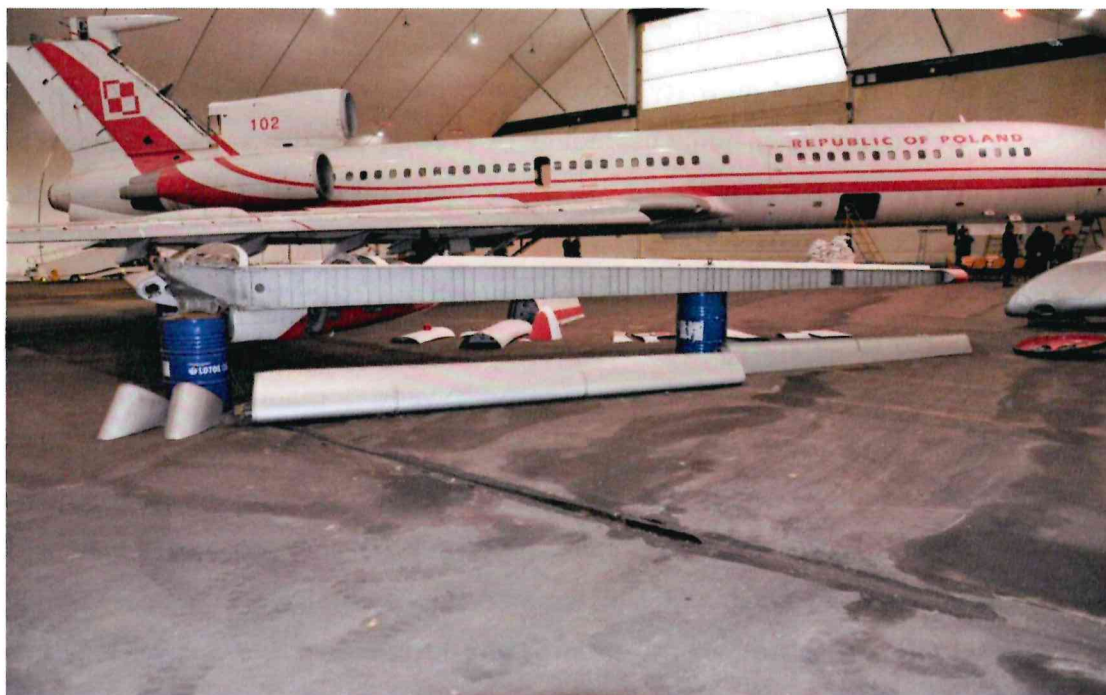
1. Ogólny widok zdemontowanego samolotu – przy kadłubie członkowie Zespołu podczas realizacji procesu badawczego.

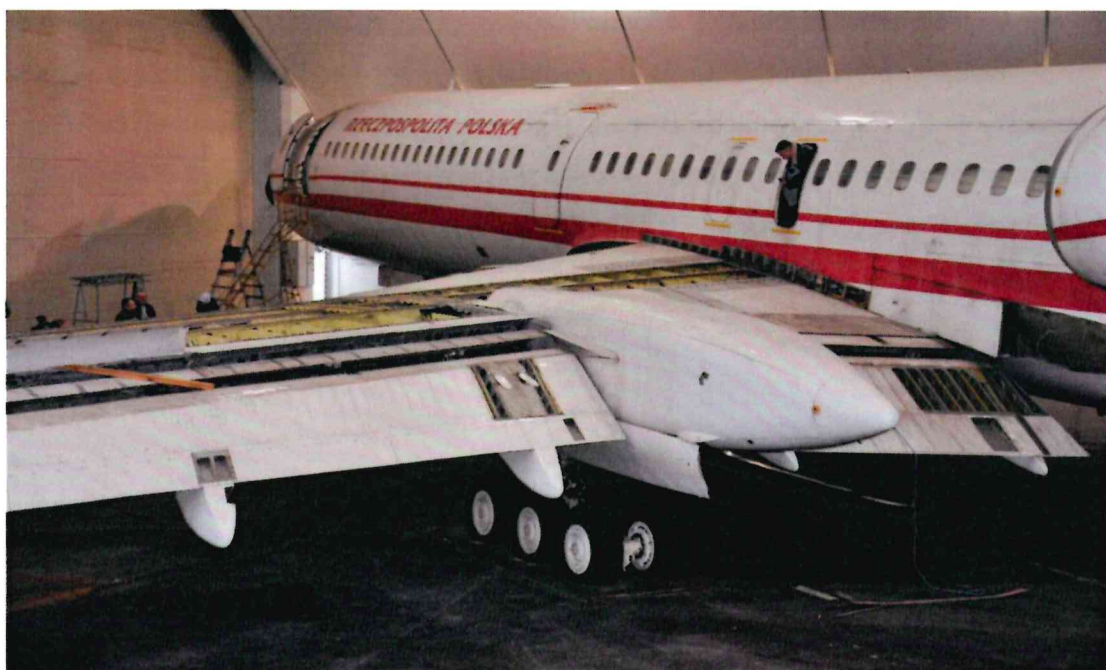
2. Zdemontowana powierzchnia górnego poszycia lewego skrzydła samolotu, brak powietrza we wszystkich kółach podwozia głównego.

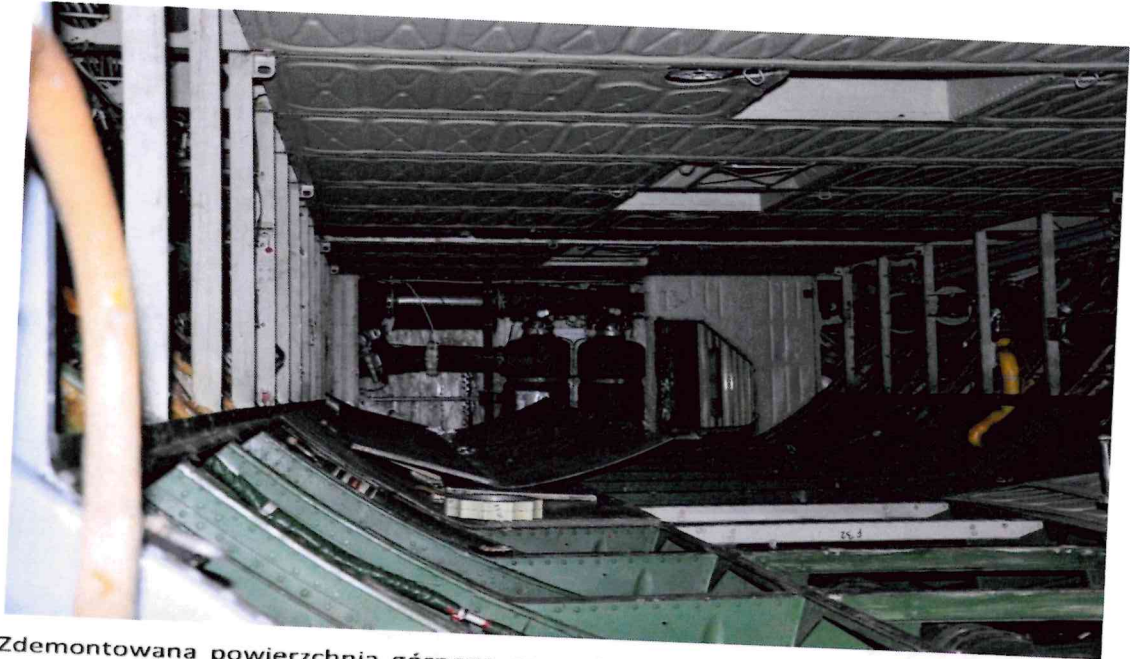
3. Zdemontowana podłoga luku bagażowego.

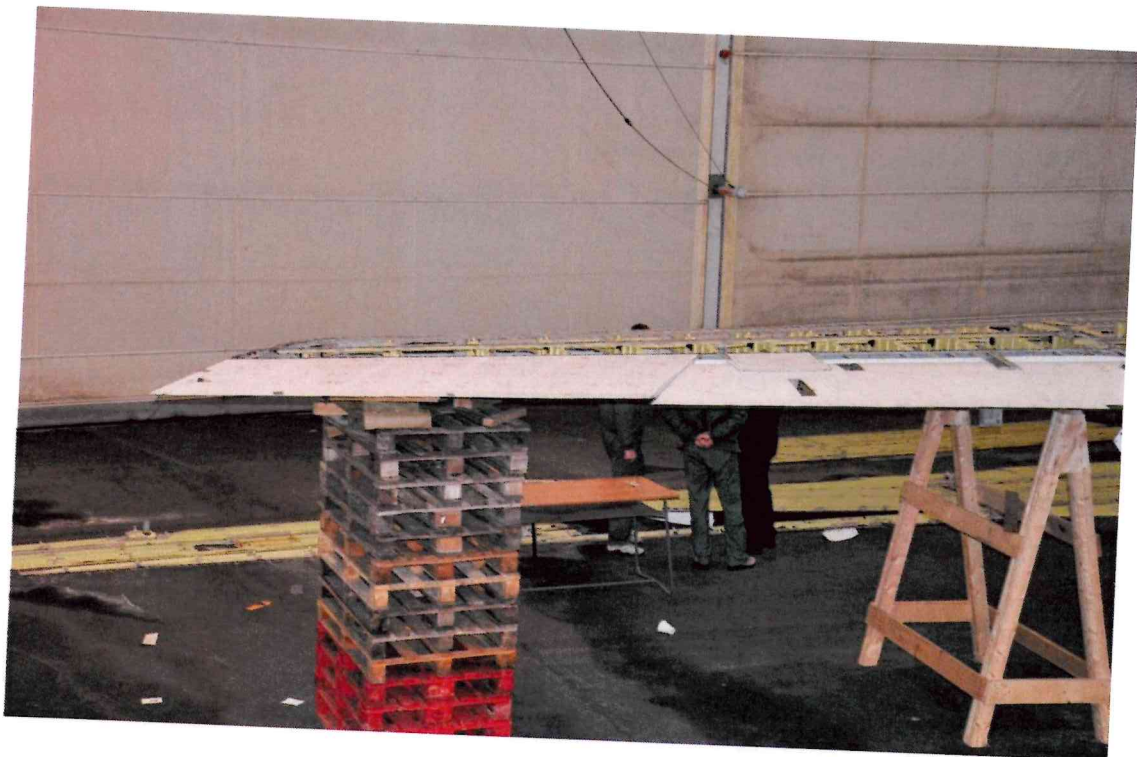
2. Zdemontowana powierzchnia górnego poszycia lewego skrzydła samolotu, brak powietrza we wszystkich kątach podwozia głównego.

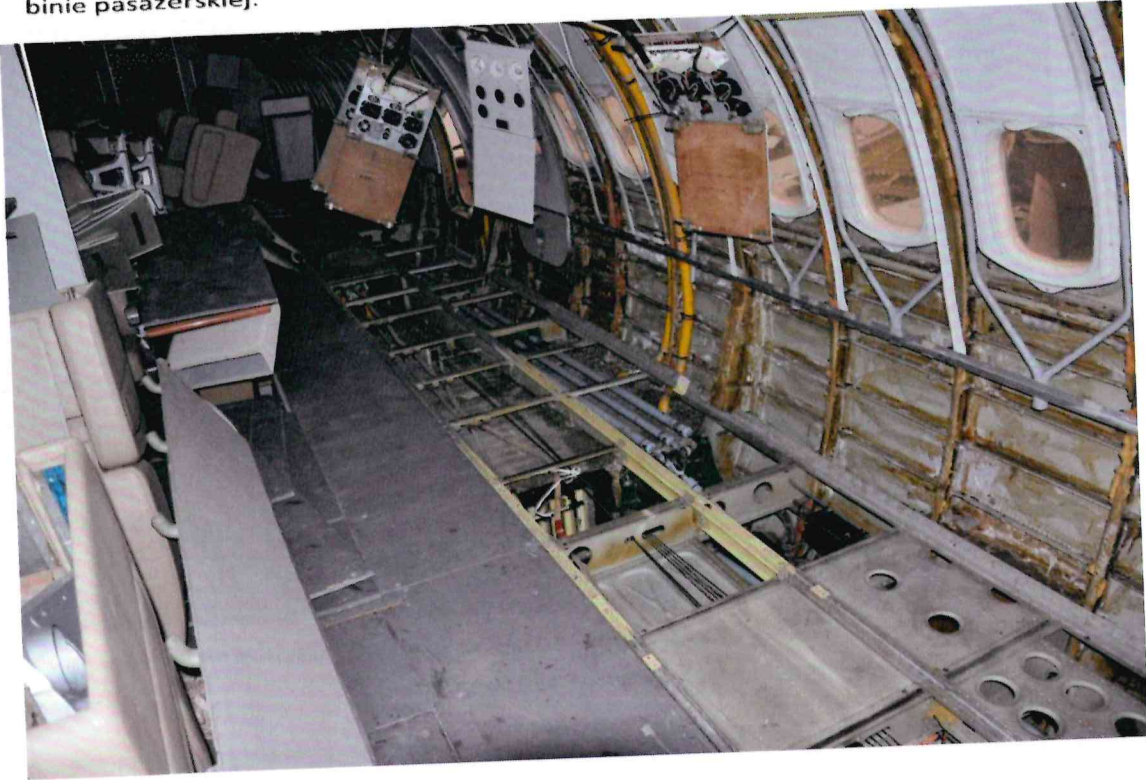
5. Zdemonstrowana podłoga, fotele oraz elementy tapicerki i izolacji ściany bocznej w kabine pasażerskiej.

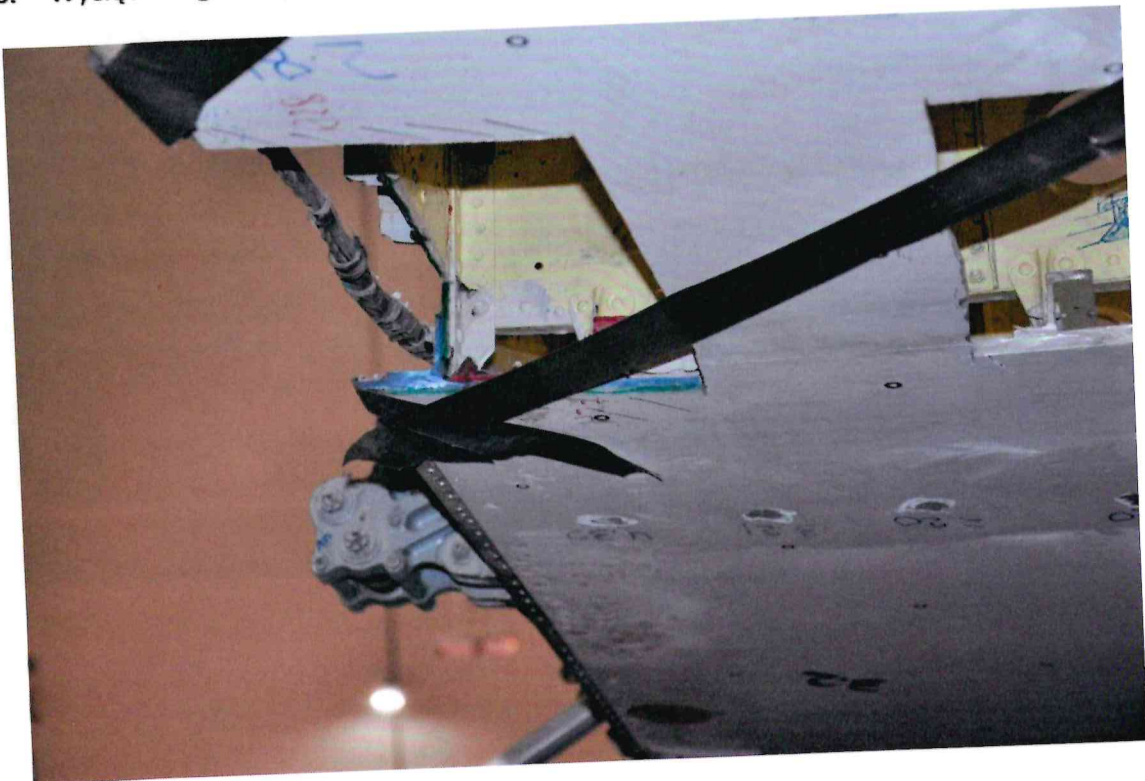
6. Wycięte fragmenty poszycia samolotu.

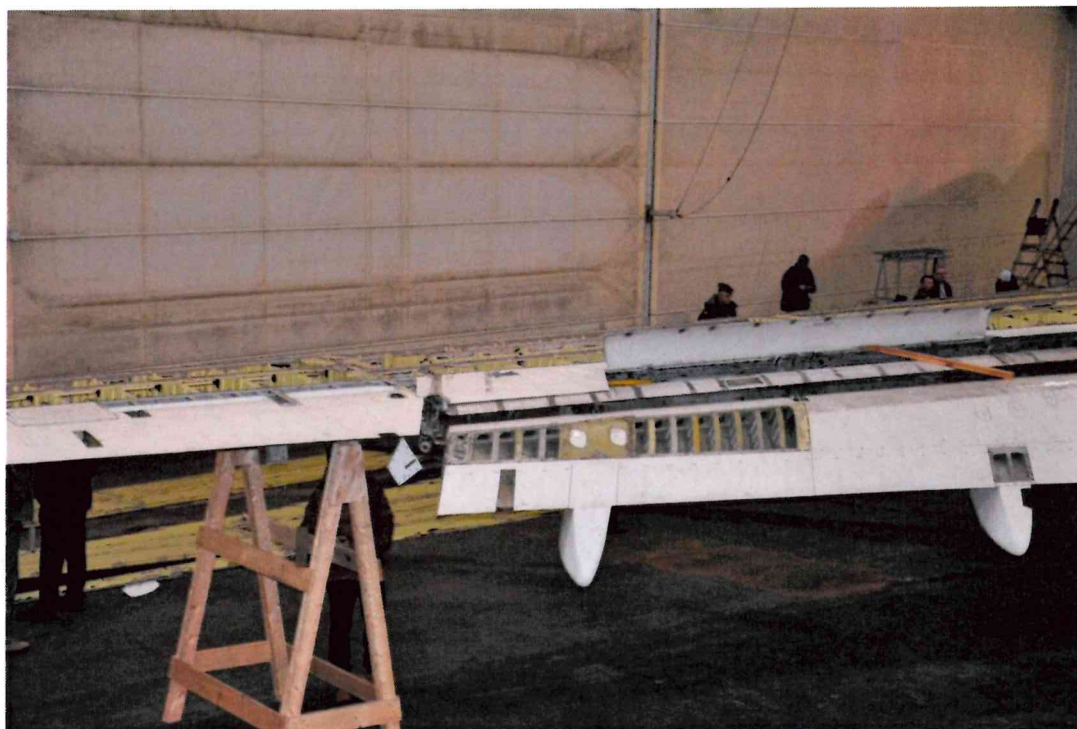
7. Wycięte fragmenty poszycia lewego skrzydła.

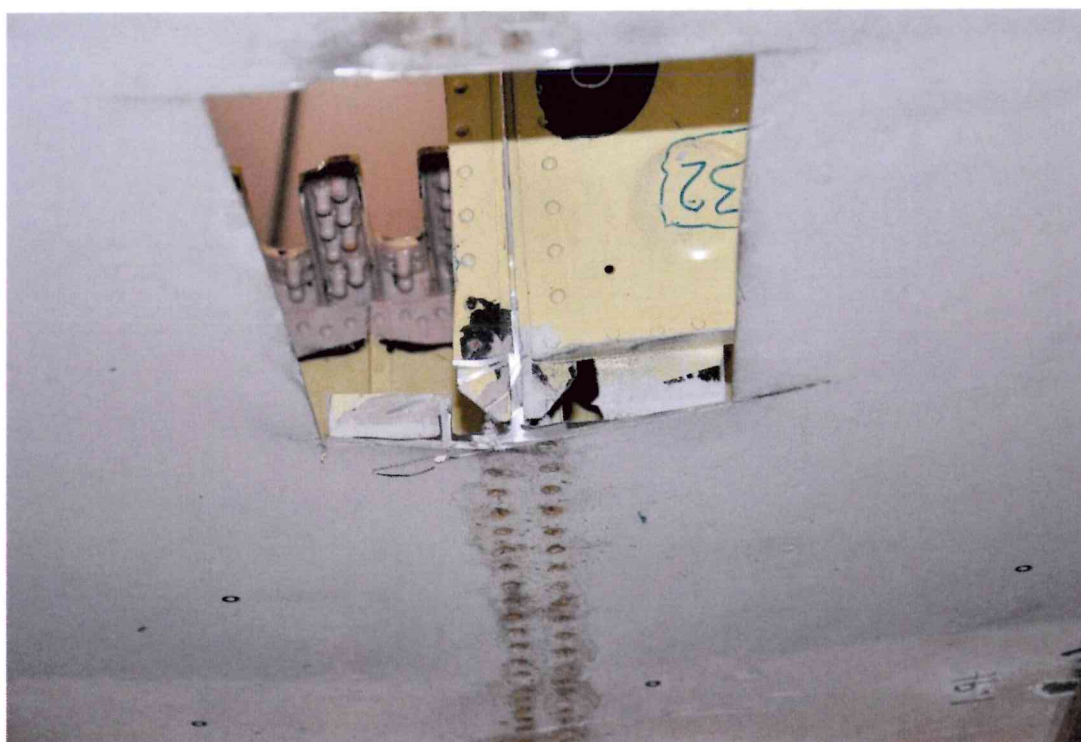
8. Wycięty fragment poszycia kadłuba.

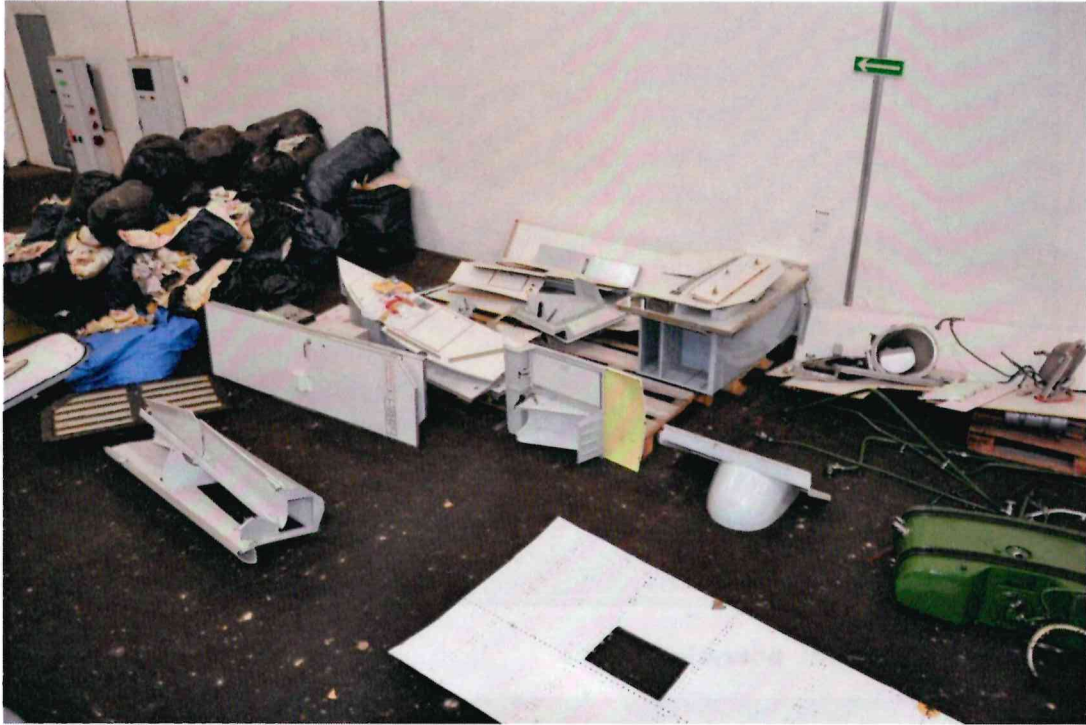
9. Zdemontowane elementy rozłączne samolotu rozmieszczone w nietadzie – uwagę zwraca brak oznaczeń umożliwiających ich identyfikację.

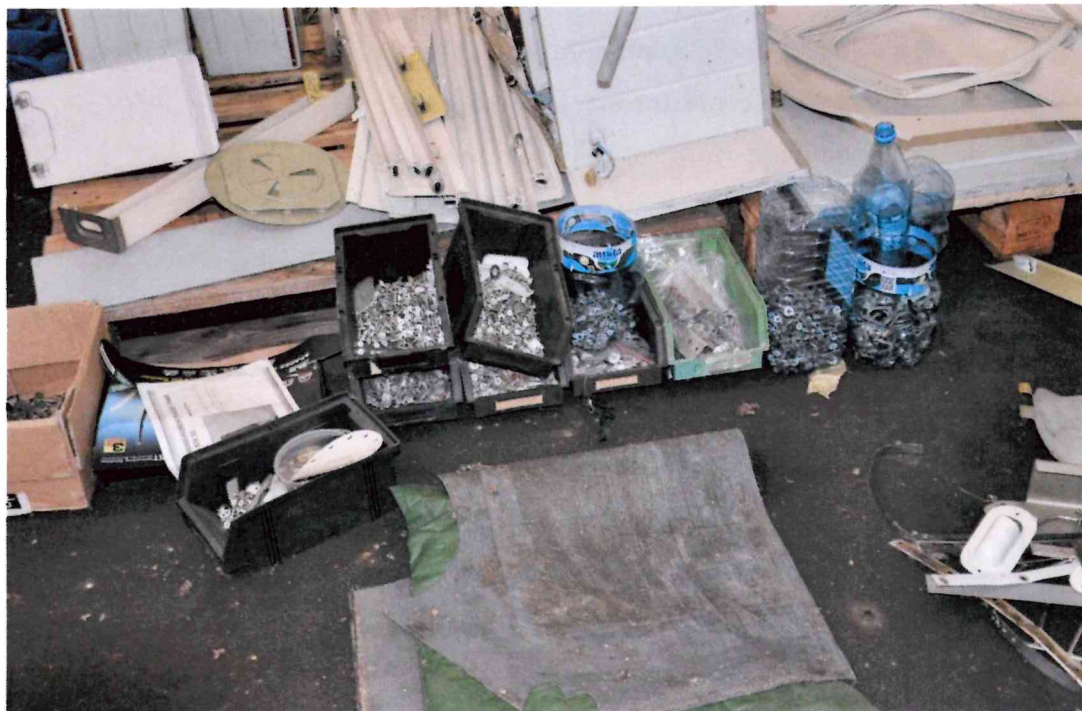
10. Zdemontowane wkręty, śruby, nakrętki – przechowywane (bez opisanie) w nieładzie.
