Report No. POL-005

**Executive Summary
Final Report: TU154M
101 Accident
Reconstruction**

2020-12-18

NIAR AVET Laboratories

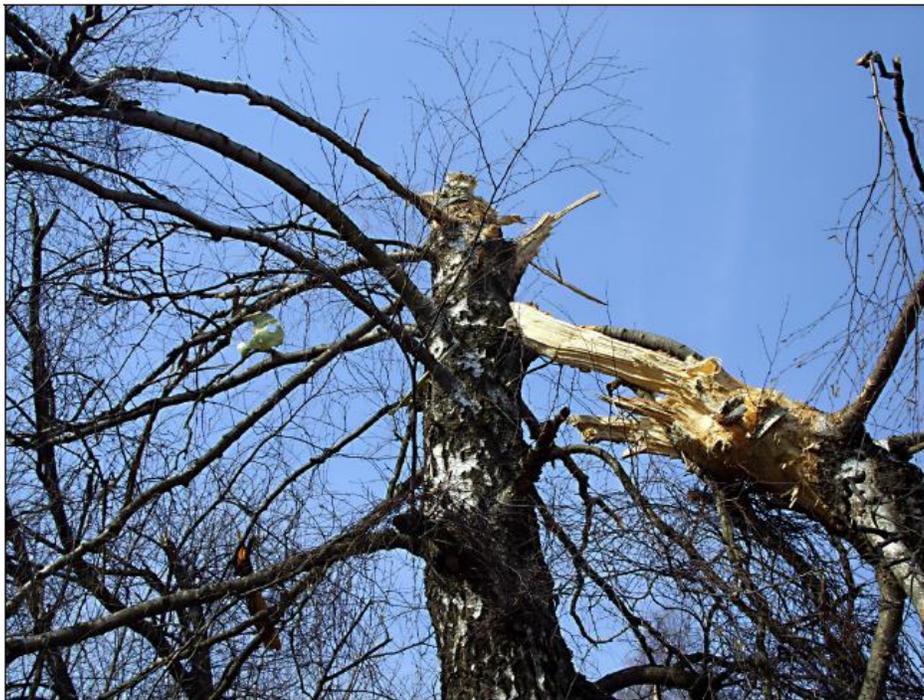
Figure 1.12 Birch tree impacted by left wing [1]

Sequentially, the first impact was with the top of a tree at the height of 11 m as shown in Figure 1.11. No parts of the aircraft were found at the first location. After the first impact and a distance of 244 m further with a lateral deviation of 61 m left from the centerline of the extended runway and at the height of about 5 meters, the aircraft wing hit a birch with a trunk of diameter measuring 30-40 cm (Figure 1.12). The investigation team found a left detachable part of the wing about 6.5 m long (Figure 1.13) at the area of impact. Followed by a hard left roll, and the aircraft further departed towards left. While rolling and moving further, the aircraft structure impacted with other trees and impacted the ground at a distance of 580 m from the first impact. The traces on the ground, shown in Figure 1.14, reveals that the impact occurred when aircraft was rolling towards left, and on impact, the aircraft was upturned with a left bank of about 200° - 210° [1].

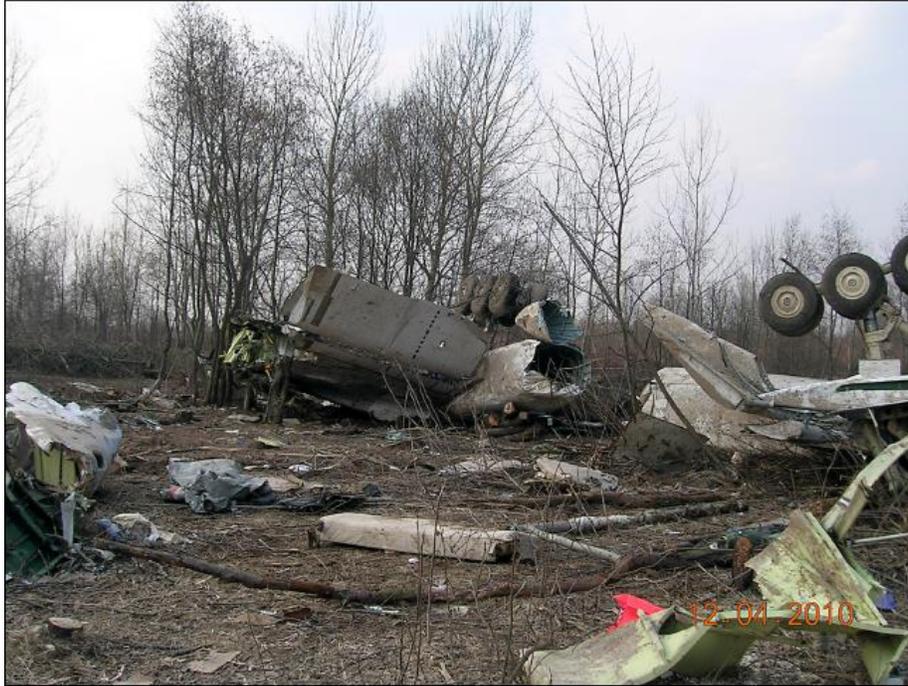
Figure 1.16 Multiple fragments of aircraft systems and airframe [1]

The whole wreckage area with multiple fragments of aircraft systems and airframe was at a distance of 670-680 m from the first impact and spread across 30-50 m wide and 130 m long along the path of the aircraft (Figure 1.16).

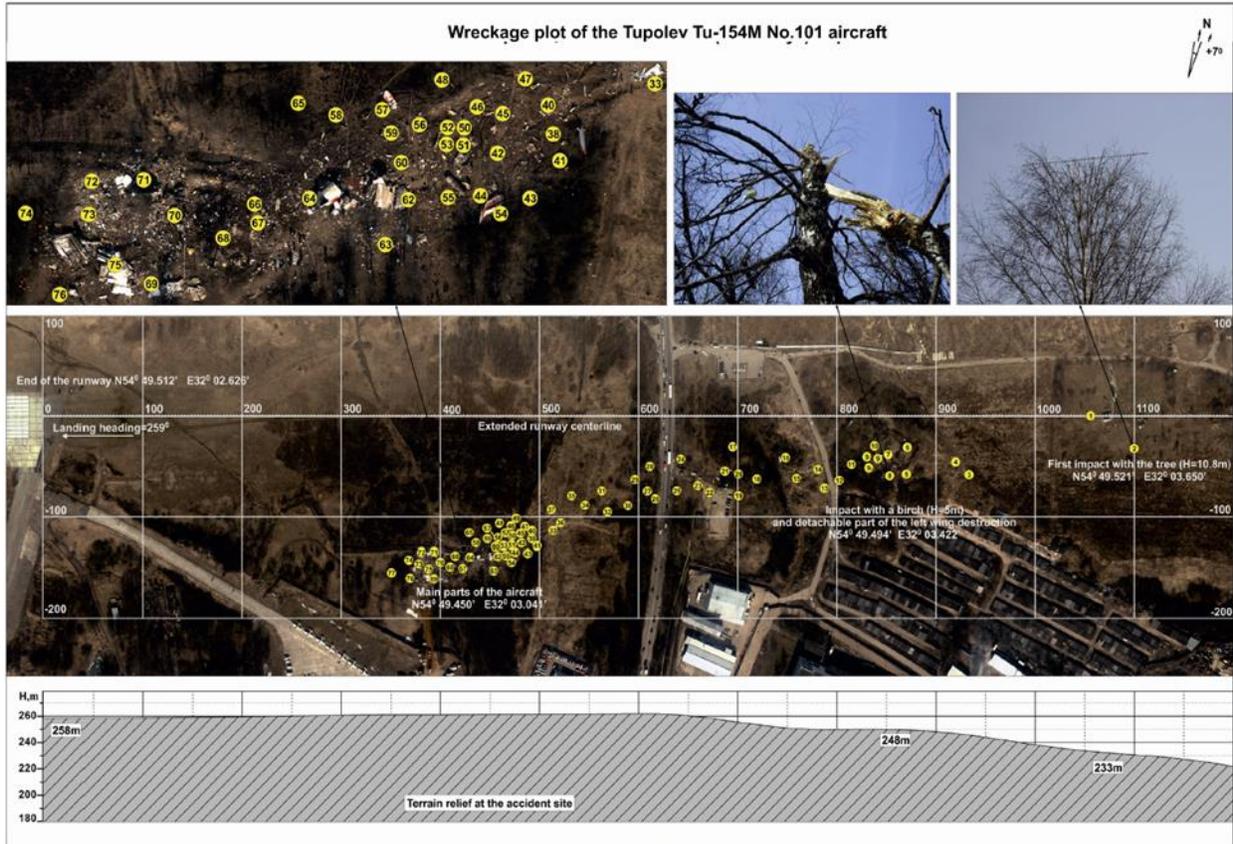
Figure 1.19 Wreckage plot [1]

The accident site is at Smolensk “Severny” Airdrome, a military airbase in Russia, a crossed terrain with hills and forest, trees around 25 m with an elevation 230-260 m above the sea level. The impact occurred before the middle marker and 1,050 m distance from the runway 26 threshold [1].

The Center of the wreckage area is located at N 54° 49.450’ and E 32° 03.041’.

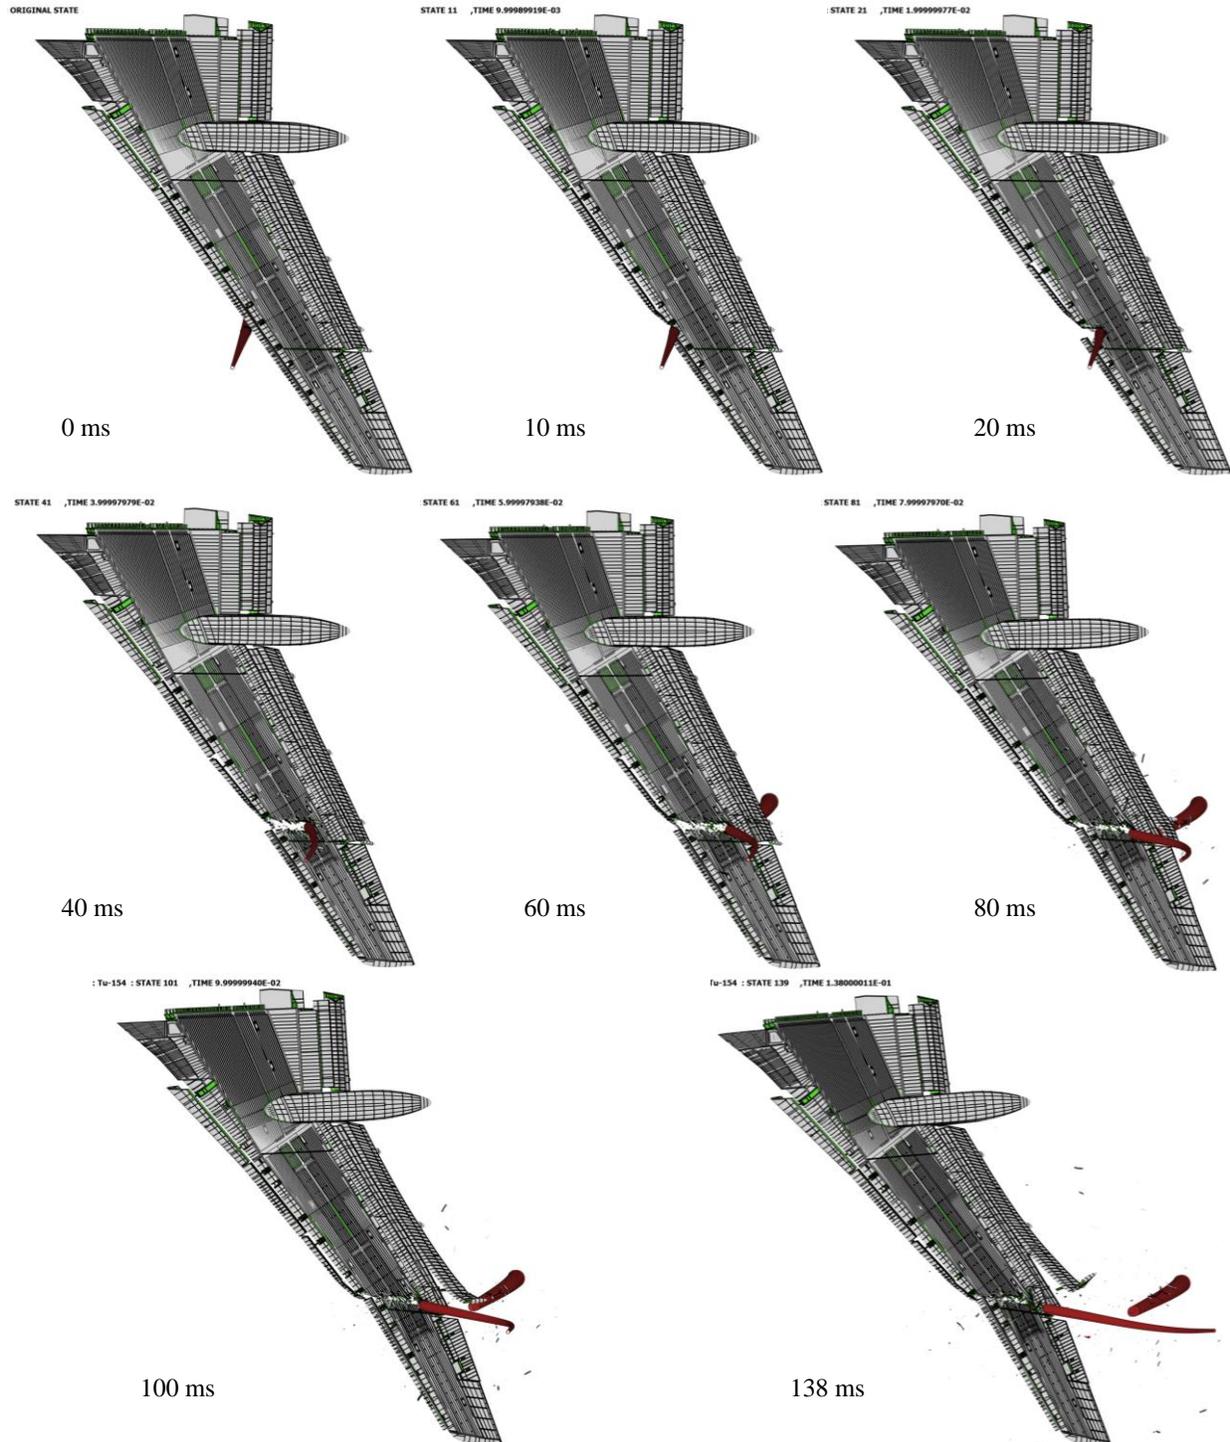
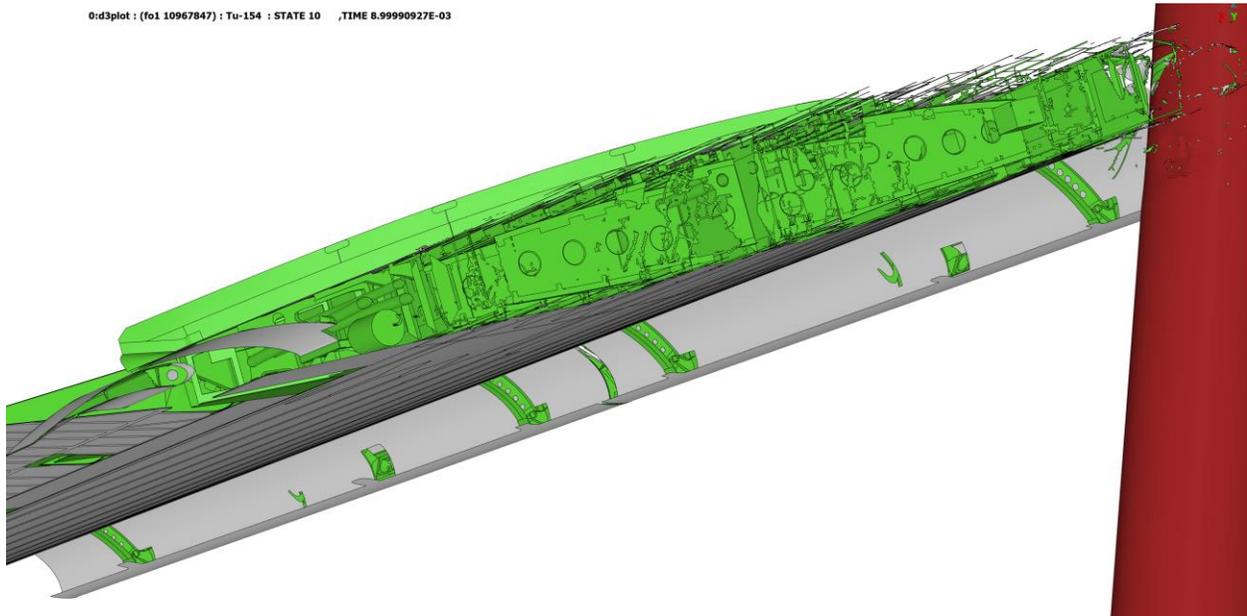
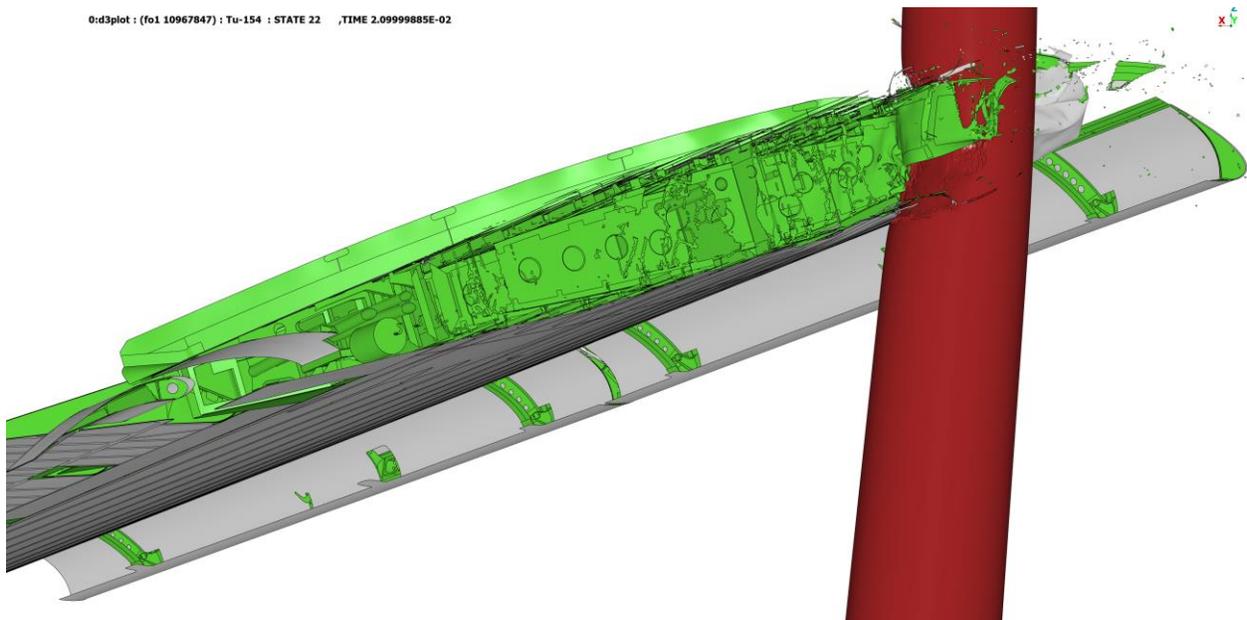
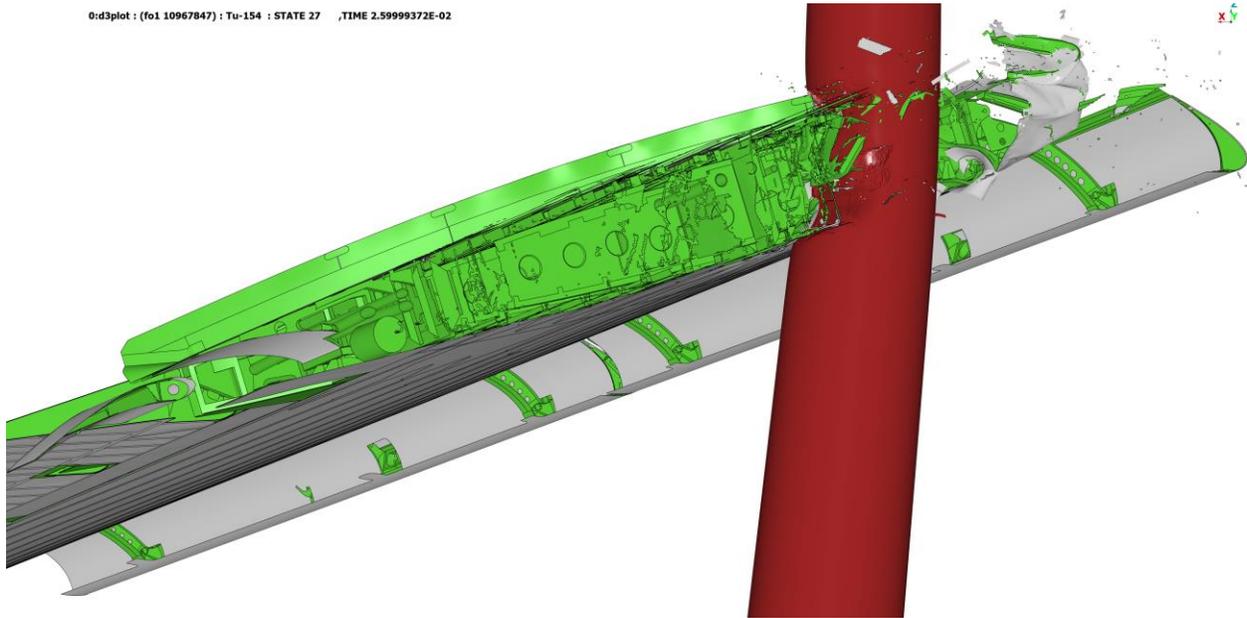
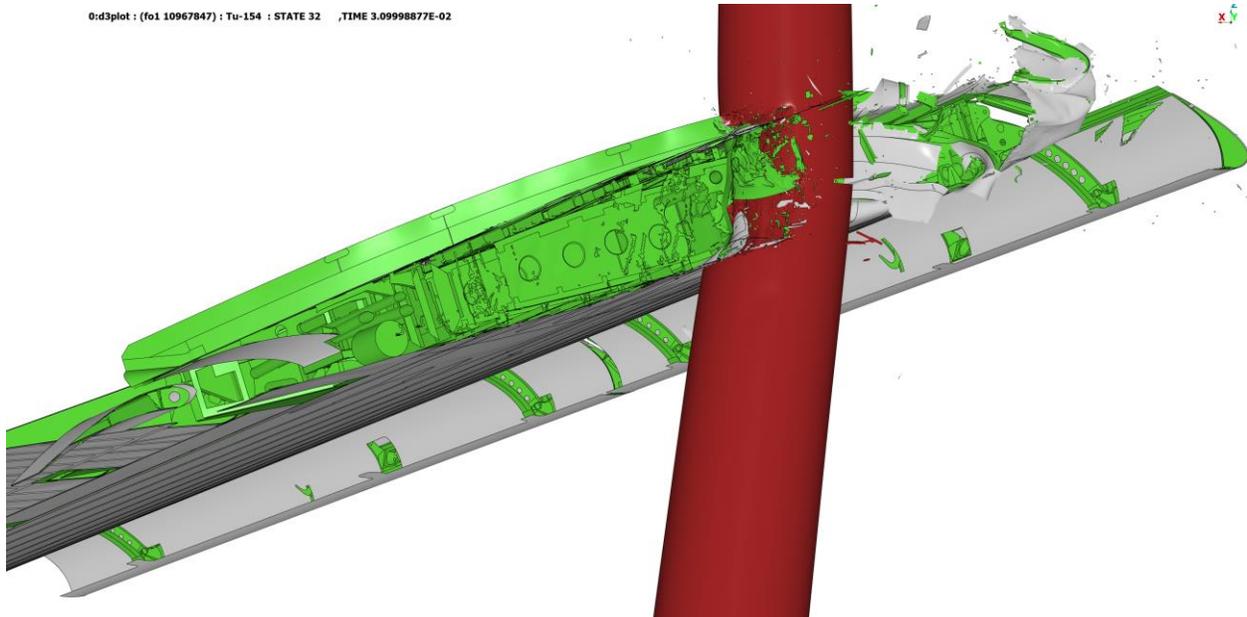
The following events were observed during the impact event between the Bodin birch tree and the left wing (see Figure 3.11 to Figure 3.17):

- From 91 to 110 ms: The upper trunk is still in contact with the rear spar (Spar 3)
 - At 110 ms: The upper trunk separates from the rear spar (Spar 3), and contact between the left wing and the Bodin Birch tree terminates

- From 110 ms to the end of the simulation (130 ms) the upper and lower birch tree trunks continue to separate as the left wing moves in the direction of flight. It should be noted that the rear spar (Spar 3) did not fail completely. The margin of safety for Spar 3 is 0.08 as shown in Table 3.5. Minor changes in Birch tree geometry and material, or wing aerodynamic loads could introduce additional forces that would be sufficient to fail spar 3.
-

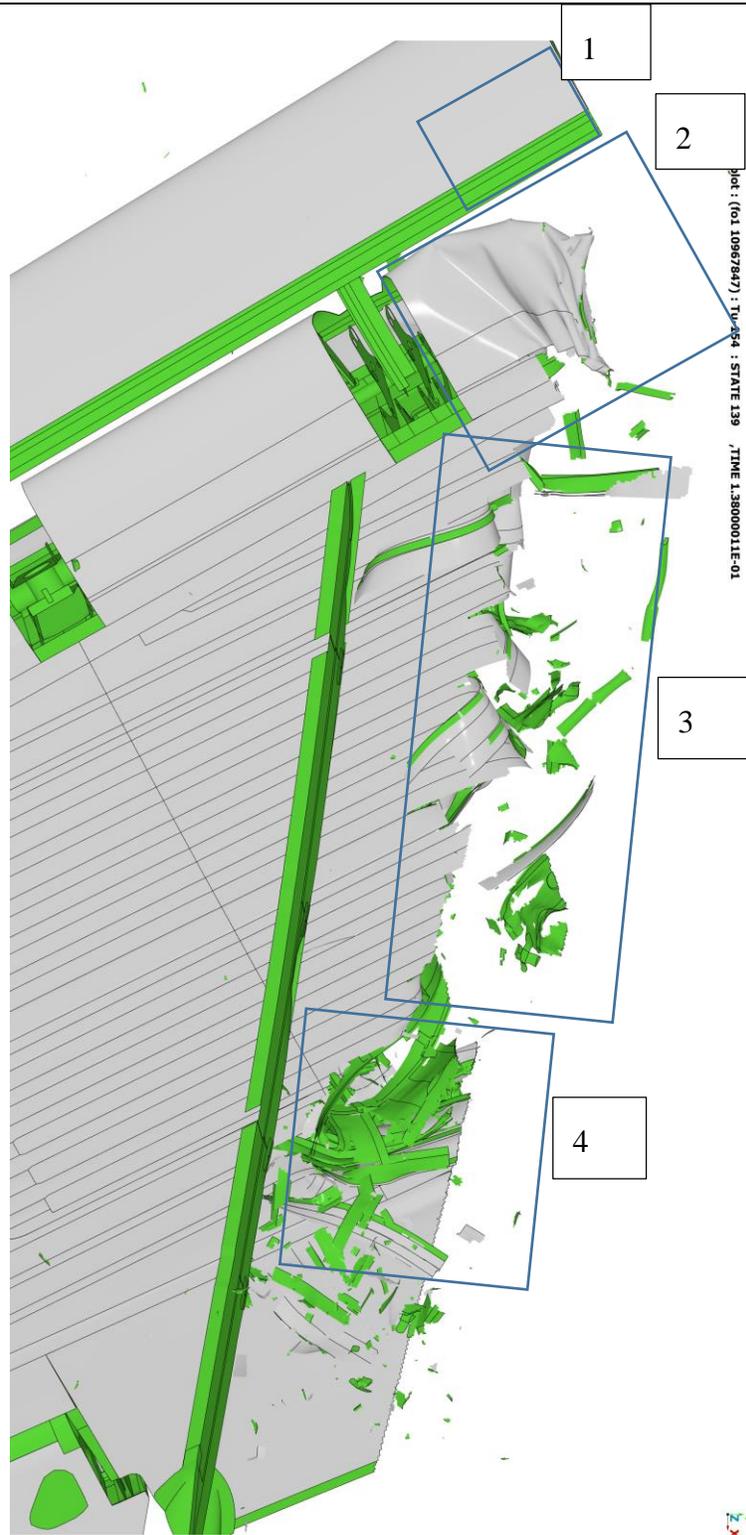
The sequence of interactions between the Bodin Birch Tree and the left wing impact are described below. The damage observations are divided into four regions as shown in Figure 3.18:

Figure 3.18 Separated wing damage – Top View (138 ms)

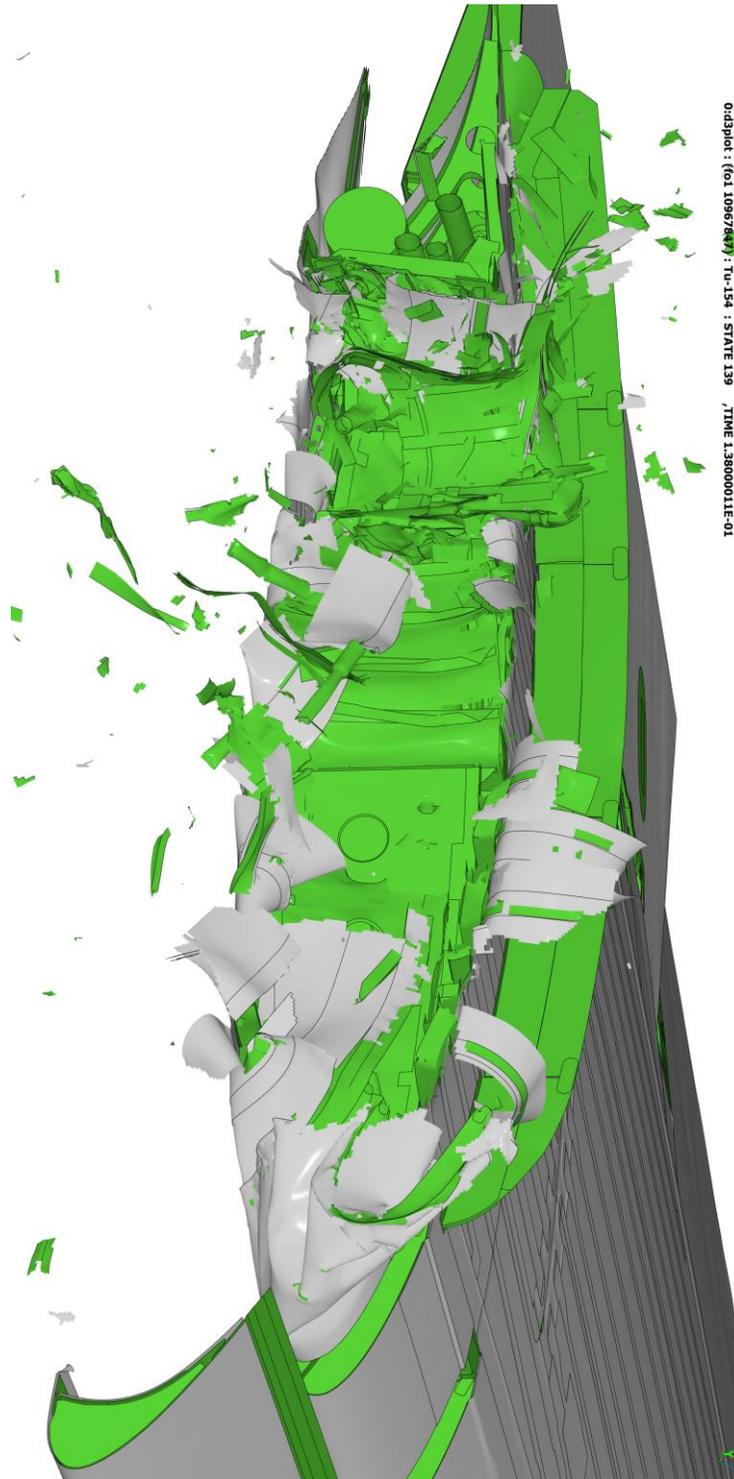
- Region 1:
 - From 0 to 10 ms: Initial impact of Bodin birch tree contact with left wing slat. No significant damage is sustained on the left slat portion of the wing as shown in Figure 3.20. The results of the simulation agree with the post impact pictures provided by the PSC [19][20].

Figure 3.20 Separated wing damage – Side View (138 ms)

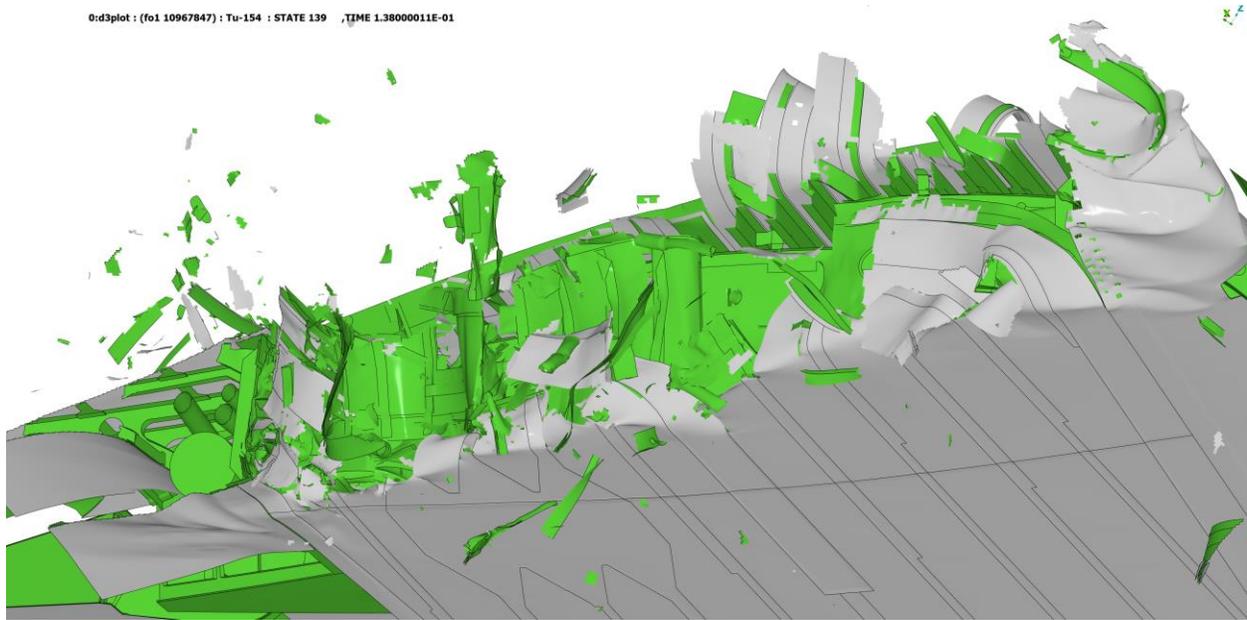
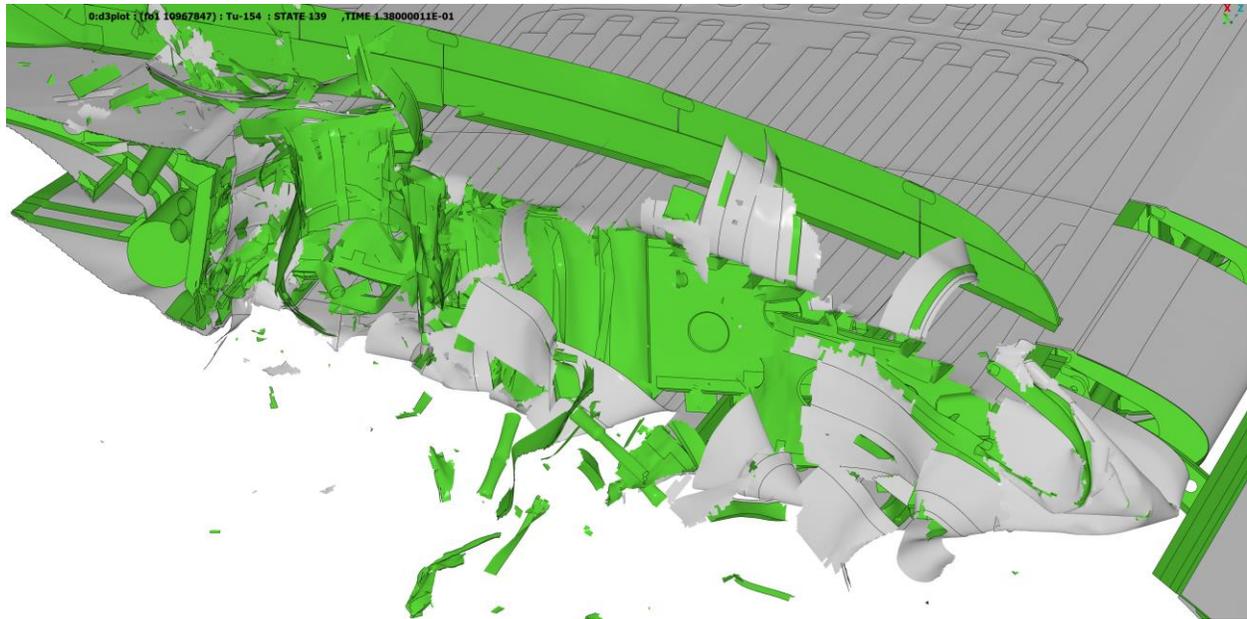
Figure 3.21 Separated wing damage – Upper and Lower Left Side View (138 ms)

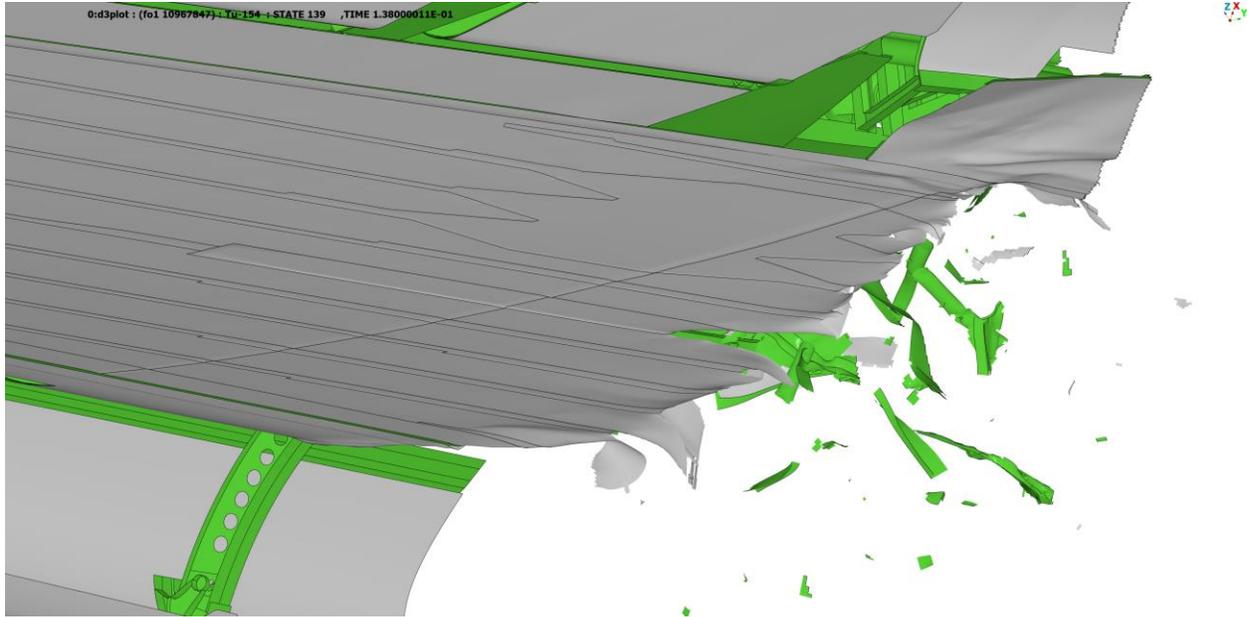
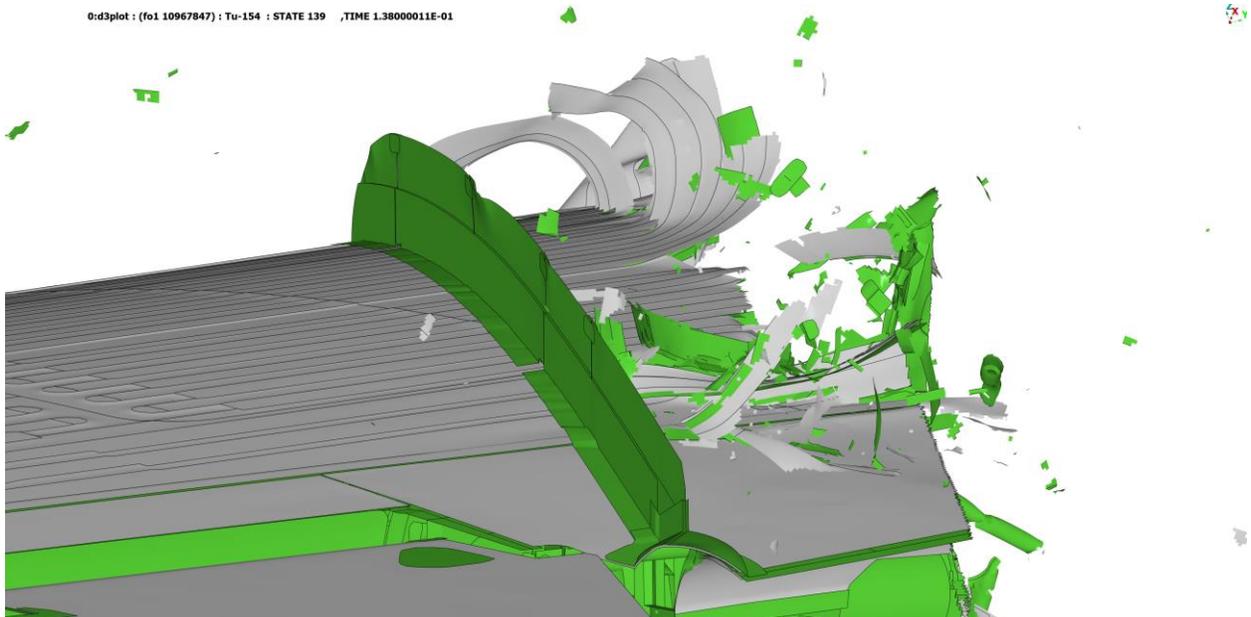
Figure 3.22 Separated wing damage – Upper and Lower Right Side View (138 ms)

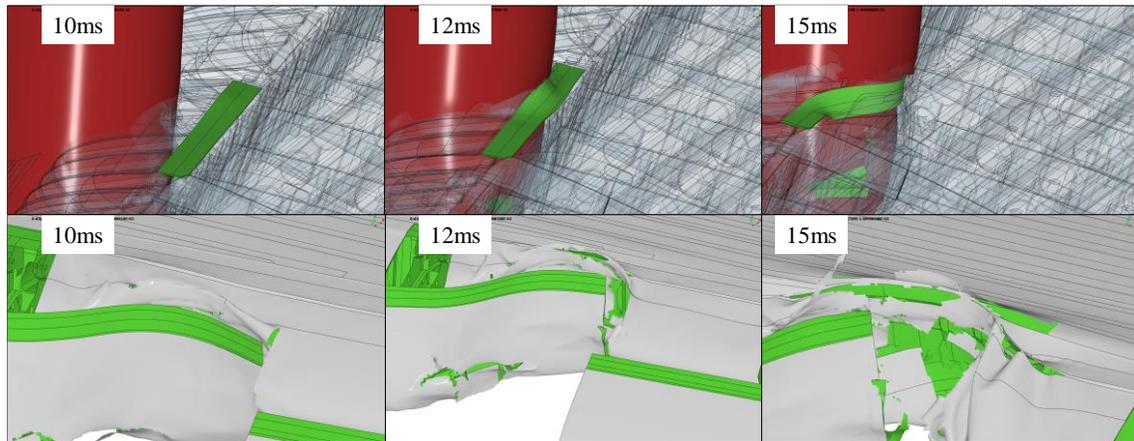
- The PSC identified pieces of the left wing slat and spar stiffener that were found embedded into the birch tree at time of accident [21]. These are shown in Figure 3.29. The MAK report also notes that the investigation team found, fragments of left wing panel embedded in the tree trunk”[1]. While the MAK report does not identify these fragments, detailed information about the fragments has been provided by the PSC [21]. The top piece is part of the upper fixed leading edge and the bottom piece is a stiffener from the front spar [21]. The kinematics of the top and bottom fragments as observed on the simulation are shown

in Figure 3.30 and Figure 3.31 respectively. In terms of similarities, it can be noted that the two parts of the wing indeed are in the path of the tree in the simulation. The simulation does not show any of the parts remaining embedded in the tree trunk. The fragment of the fixed leading edge fragment bends upwards in the simulation, while in the actual accident, it is bent upwards and embedded into the tree. This is also illustrated in Figure 3.30, which shows that the skin of the front leading edge ruptures at 12 ms allowing direct contact of the top piece with the tree trunk. The spar stiffener fragment, shown in Figure 3.31, also does not get embedded in the tree impact simulation. In the simulation, the stiffener piece is positioned towards the left side of the tree and does not experience a head on impact with the tree trunk. In addition, there are several damaged parts of the slat and leading edge of the wing in-between the stiffener and the tree.

Figure 3.30 Top fragment analysis in tree impact simulation

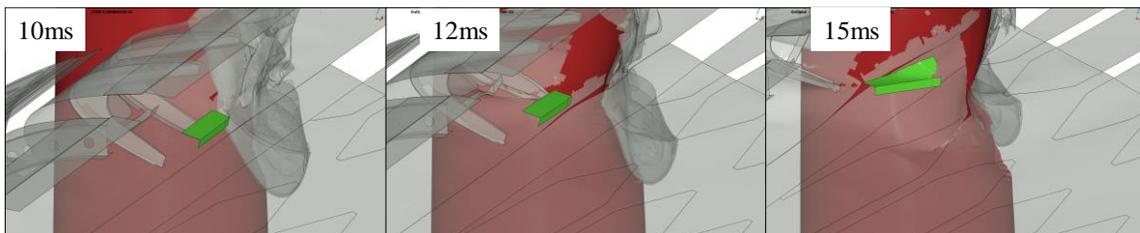
Figure 3.31 Bottom fragment analysis in tree impact simulation

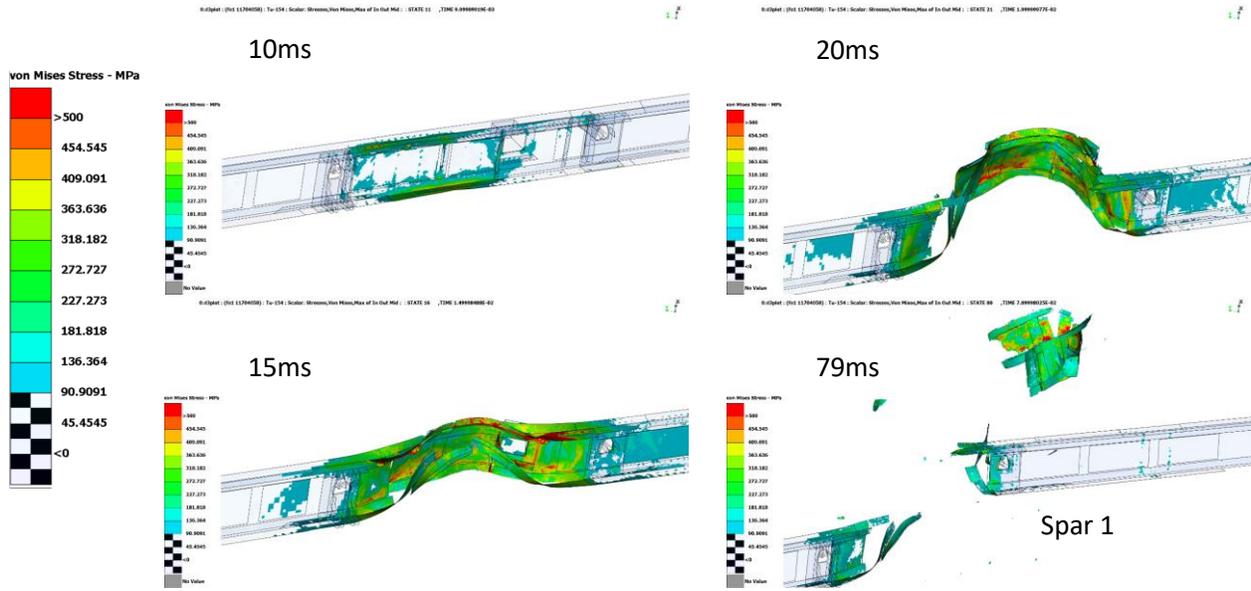
- Region 2:
 - From 10 to 20 ms: Interaction between the Bodin Birch tree, leading edge and spar (Spar 1). As shown in Figure 3.19 the leading edge is plastically deformed due to the compressive loads exerted by the tree impact. Similar deformations are observed in the pictures provided by the PSC [19][20].
 - From 20 to 26 ms: The front spar (spar 1) fails (see Figure 3.32).

Figure 3.32 Von Mises stresses on Spar 1 - MPa

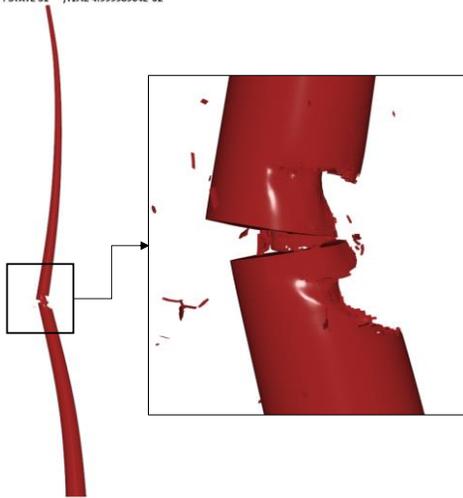
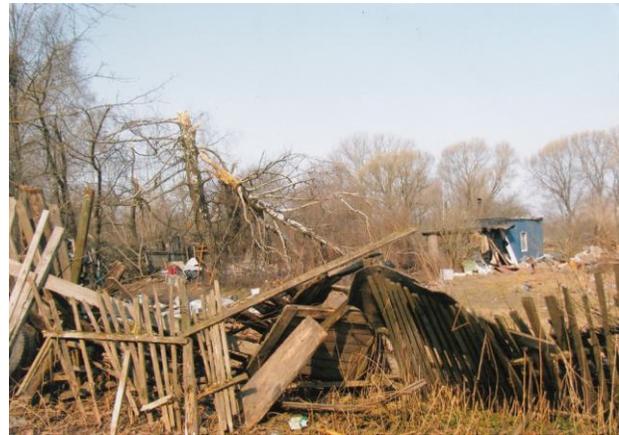
The simulation shows that the tree trunk breaks in two major pieces as observed in the photos reported in the MAK report [1] and those provided by the PSC [19]. The tree splits into two parts at 50 ms after initial impact, as shown in Figure 3.17 and Figure 3.34. Detailed view of the tree damage is shown in Figure 3.35. The analysis does not capture all the failure mechanisms (such as fiber splitting) of the tree because the simulation cannot capture the individual fibers that define the tree structure. Nevertheless, the analysis shows good agreement with the overall tree failure mechanisms.

Figure 3.34 Tree impact analysis – tree damage view 1

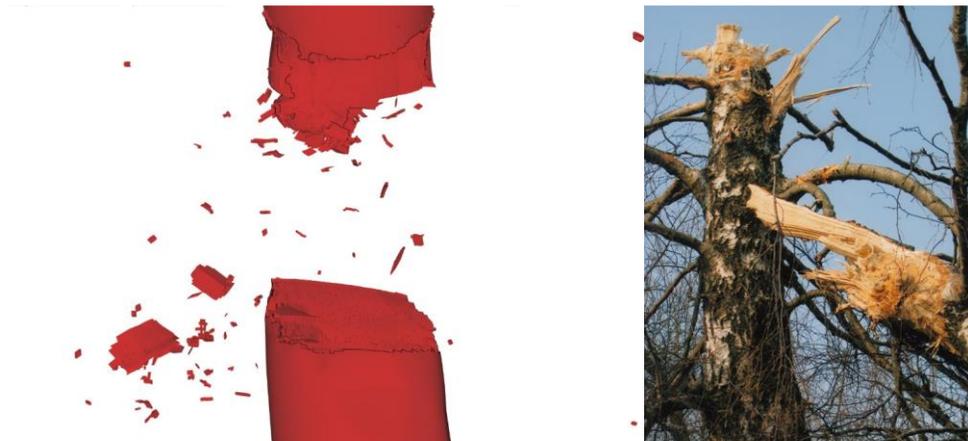
Figure 3.35 Tree impact analysis – tree damage view 2

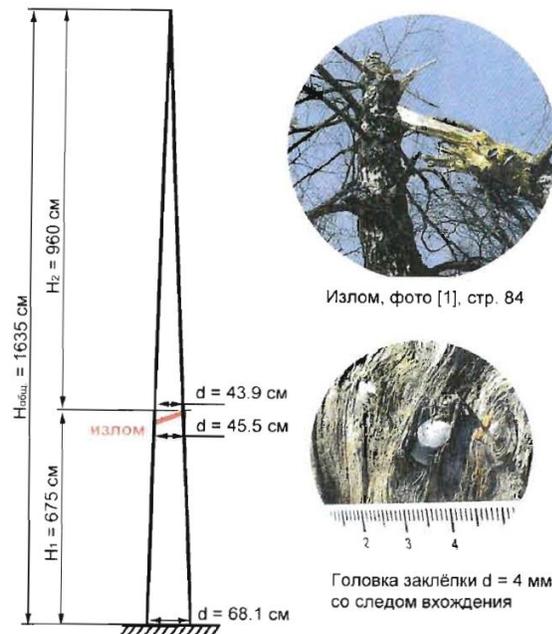
- According to the MAK report, page no. 74, the aircraft hit a birch tree trunk measuring 30-40 cm in the diameter. The diameter of this tree trunk is underestimated in the MAK report. The documentation obtained in the prosecutor report [11] indicates that the diameter of the tree at impact location was 44-45cm, as shown in Figure 3.43.

Figure 3.43 Tree dimensions drawing in Prosecutor report [11]

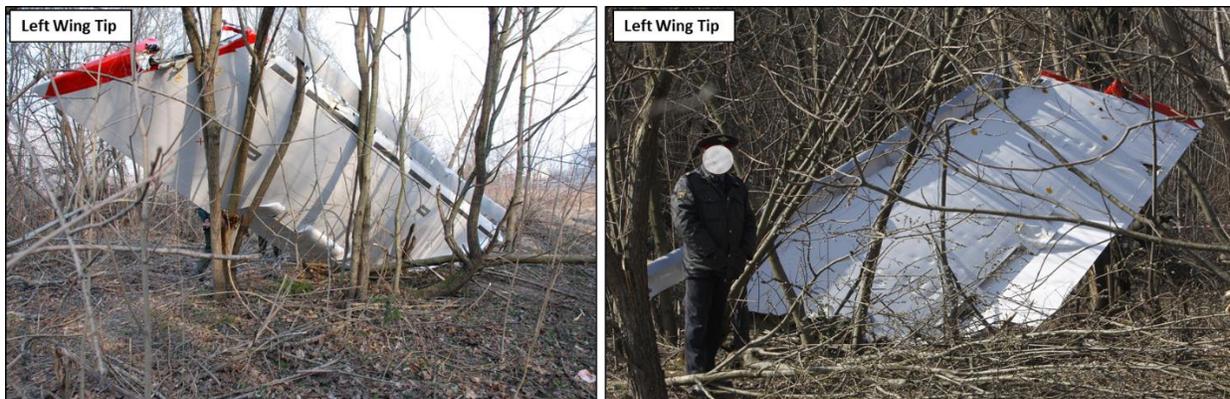
The Bodin birch debris region has fragments of the left wing, which is associated by MAK report [1] to the impact with the tree. Figure 4.15 presents the satellite image of the Bodin birch debris region on the 10th of April of 2010, indicating the location of the Bodin tree and left wing tip fragment. The grid overlaid on Figure 4.15 divides the image on areas of 10x10 meters. Figure 4.16 shows the large debris located in this region, which corresponds to the left wing tip.

Figure 4.16 PSC large debris images – left wing tip [6]

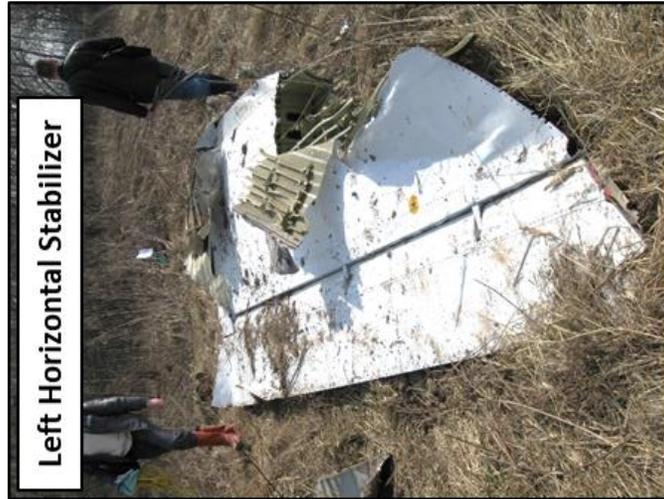
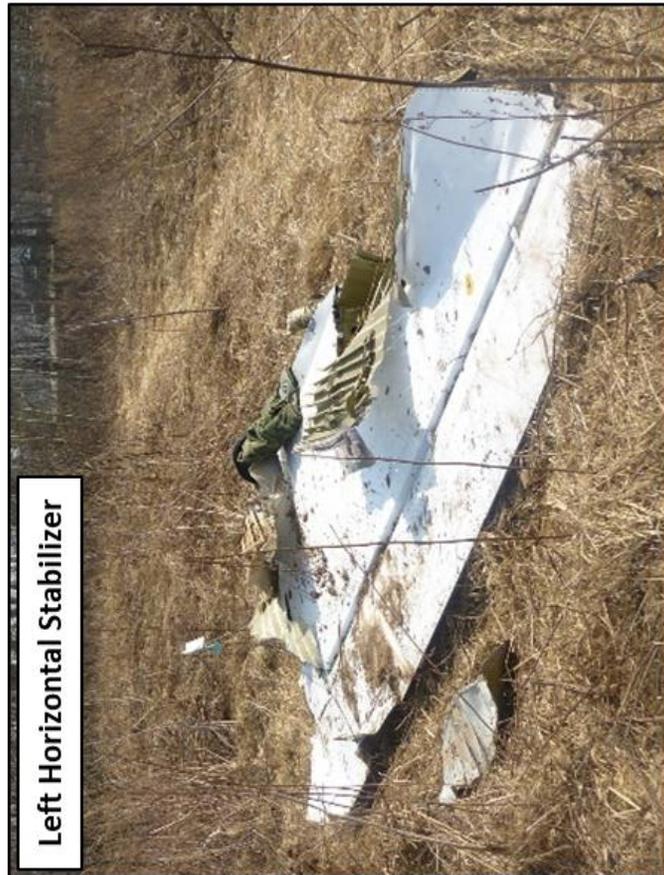
Figure 4.17 presents the satellite image of the pre-ground impact debris region on the 10th of April of 2010, specifying the location of the left horizontal stabilizer fragment. The grid overlaid on Figure 4.17 divides the image on areas of 10 x10 meters. Figure 4.18 shows the large debris located in this region, which corresponds to the left horizontal stabilizer.

Figure 4.18 PSC large debris images – left horizontal stabilizer [6]

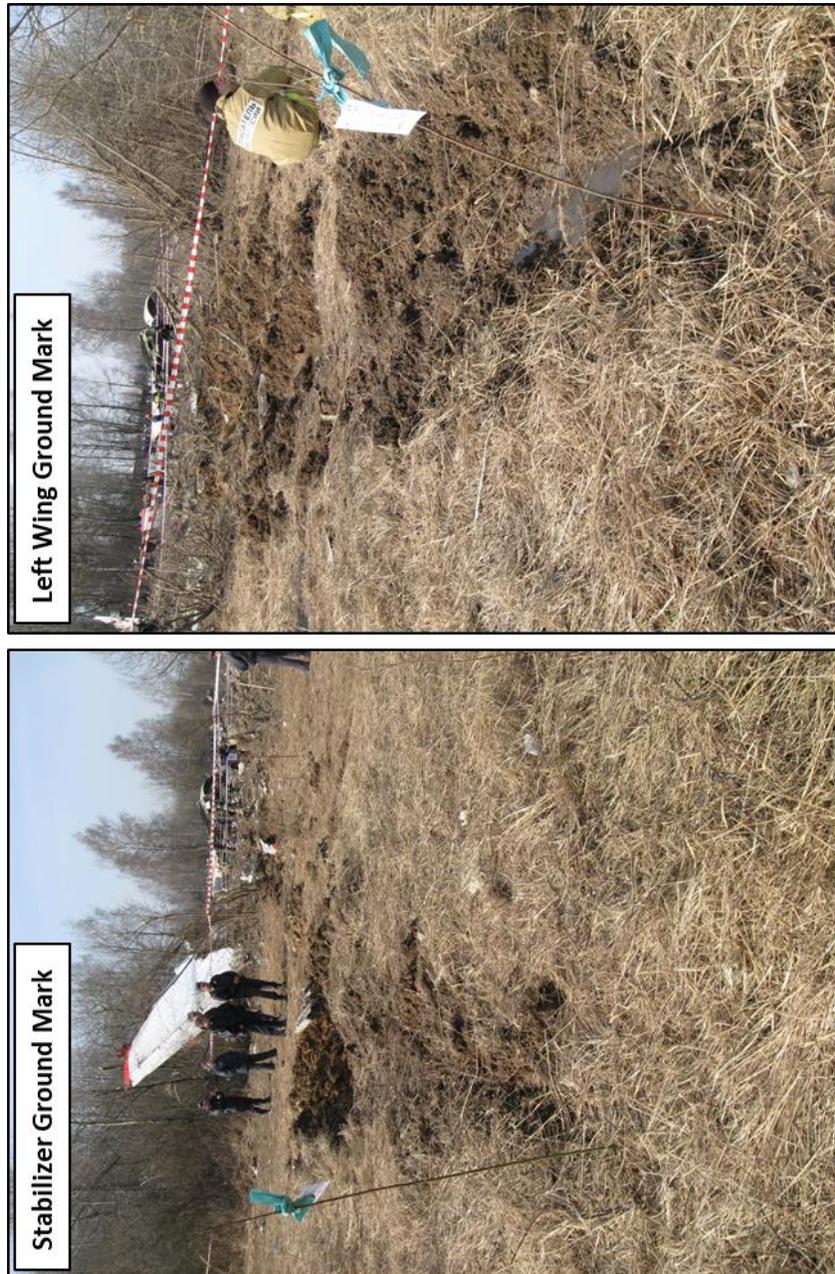
Figure 4.20 illustrated the ground marks located in the boundary between Figure 4.17 and Figure 4.19, where the pre-ground impact debris region ends and the post-ground impact debris region begins. These marks are associated to the stabilizer and the wing contact with the ground according to the accident reconstruction description provided by the MAK report [1].

Figure 4.20 PSC ground marks images [6]

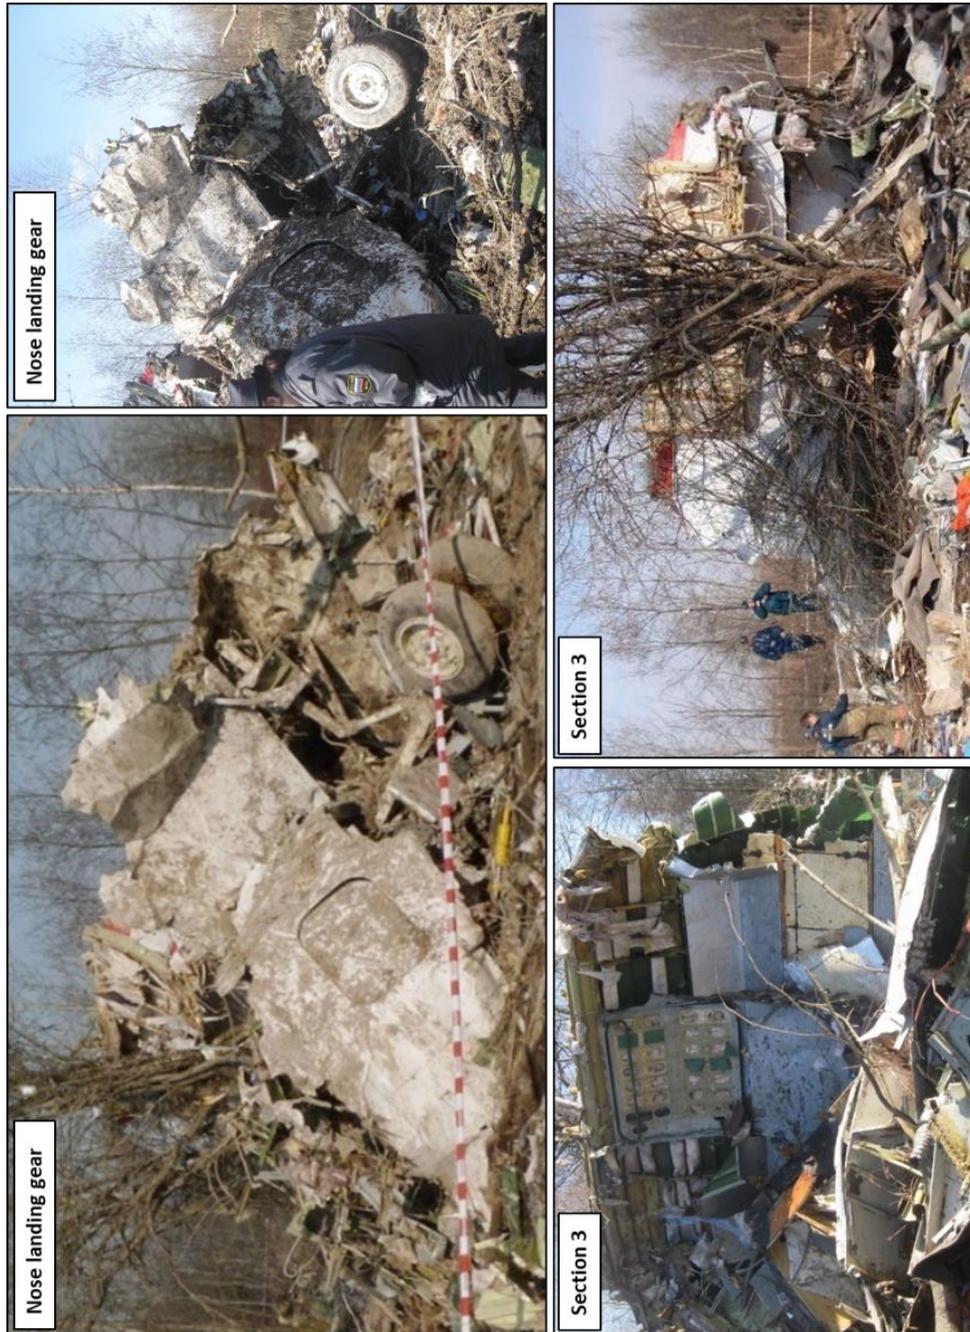
Figure 4.21 PSC large debris images – Section 1-2-3 [6]

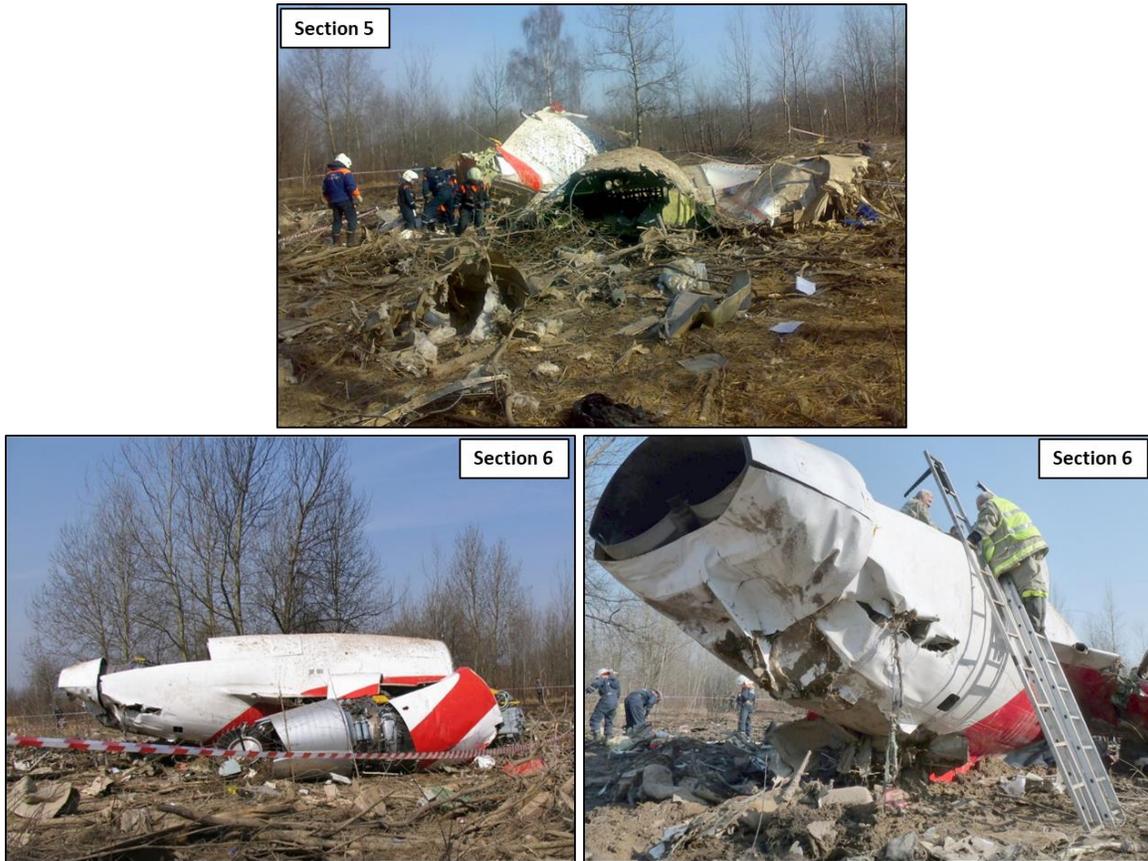
Figure 4.22 PSC large debris images – Section 5-6 [6]

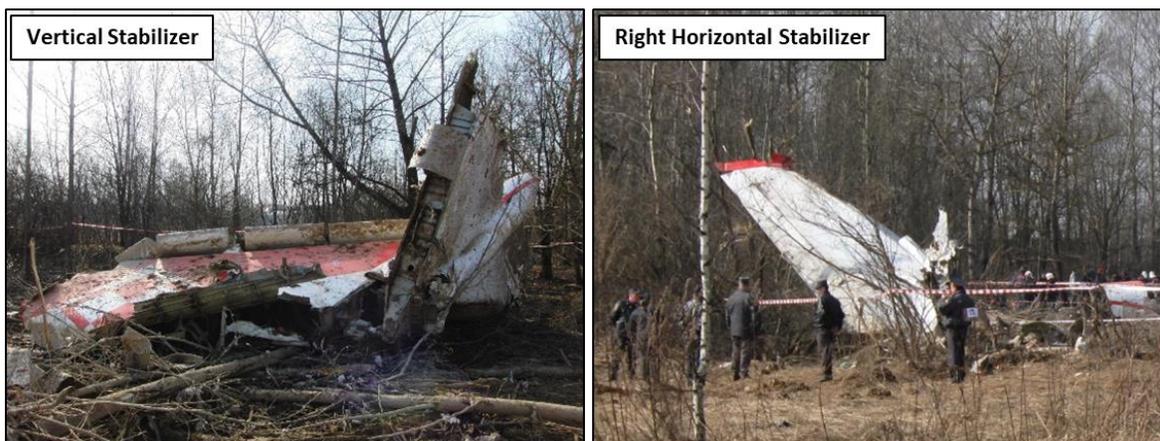
Figure 4.23 PSC large debris images – Stabilizers [6]
