Report No. POL-005

**Executive Summary
Final Report: TU154M
101 Accident
Reconstruction**

2020-12-18

NIAR AVET Laboratories

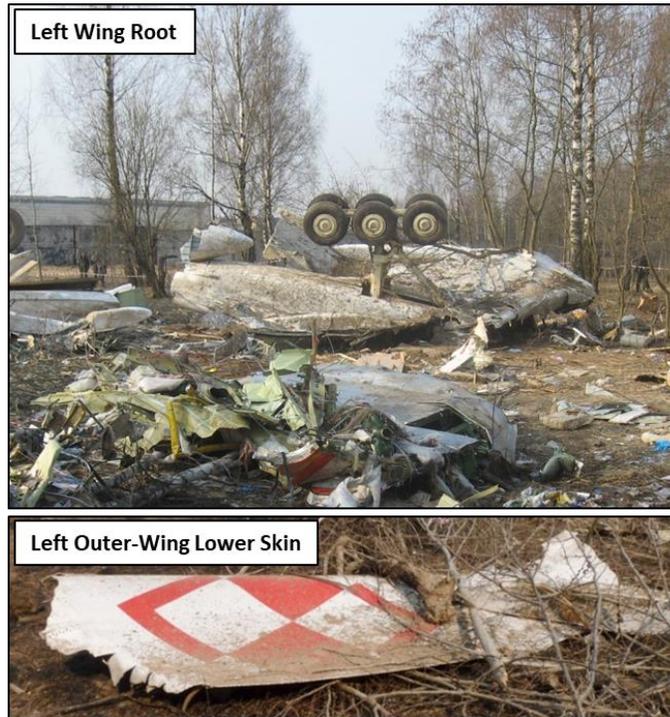
Figure 4.24 PSC large debris images – Left wing [6]

Figure 4.21 through Figure 4.25 show the large debris documented in this region, which comprise of to the aircraft fuselage fragments, engines, right wing, tail and the majority of the left wing structure.

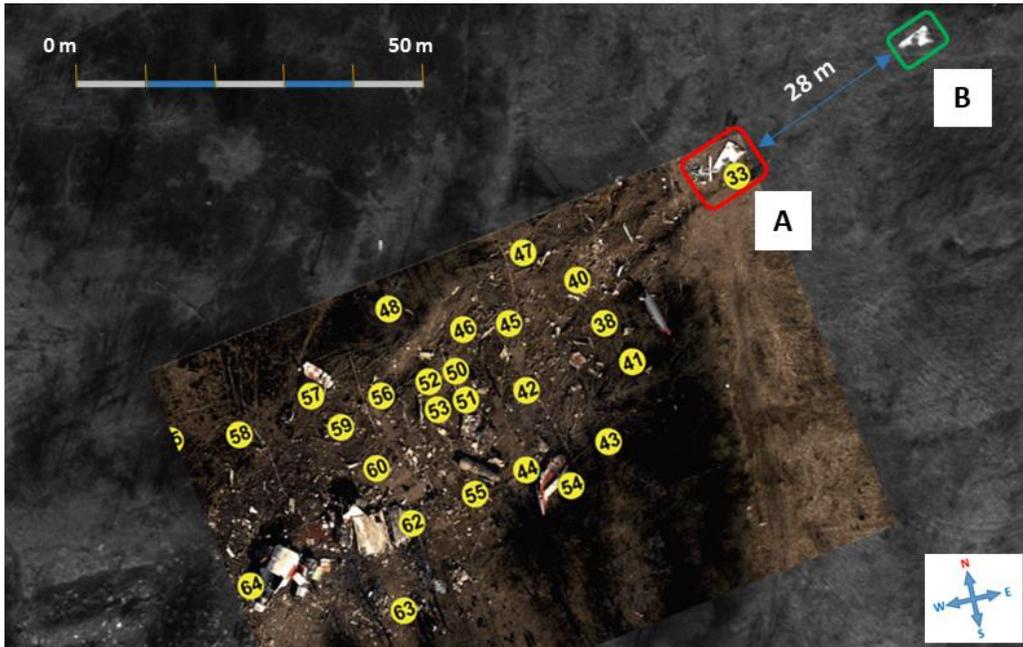
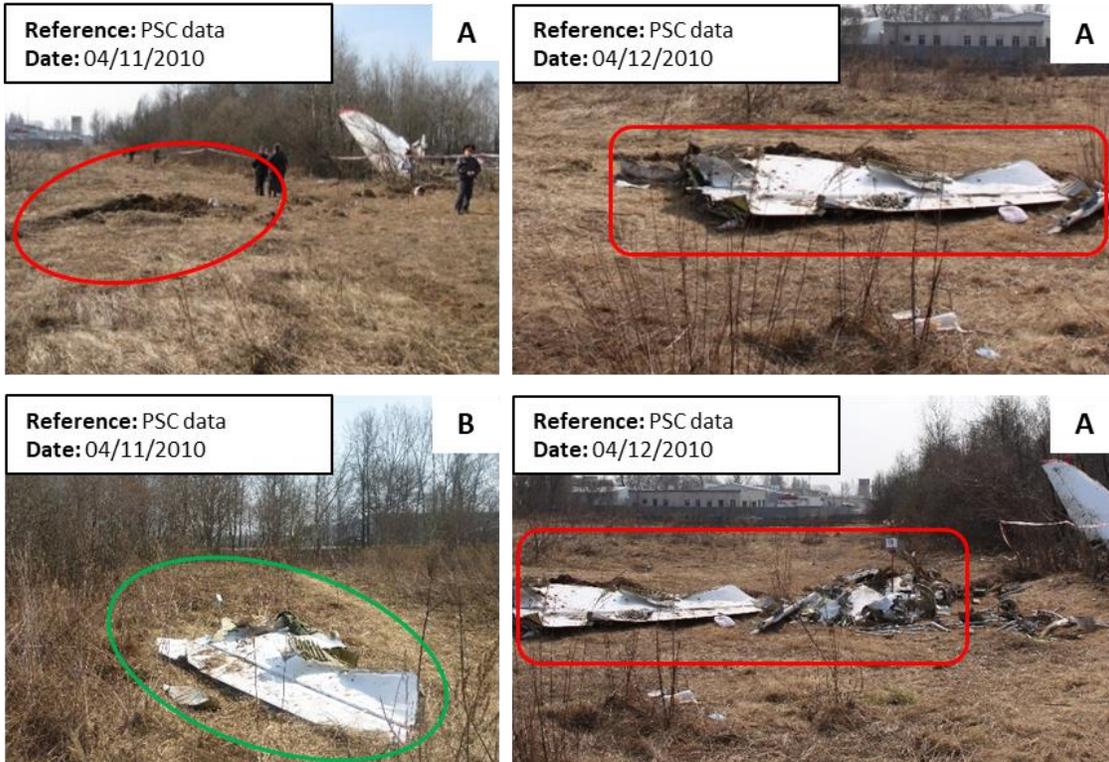
Figure 4.30 Left stabilizer debris alteration

Upon overlaying both images, the location of the left stabilizer had a difference of 28 meters approximately. Figure 4.30 presents the distance discrepancy between both images and attaches the images collected by PSC of the location of the left stabilizer prior and after being moved.

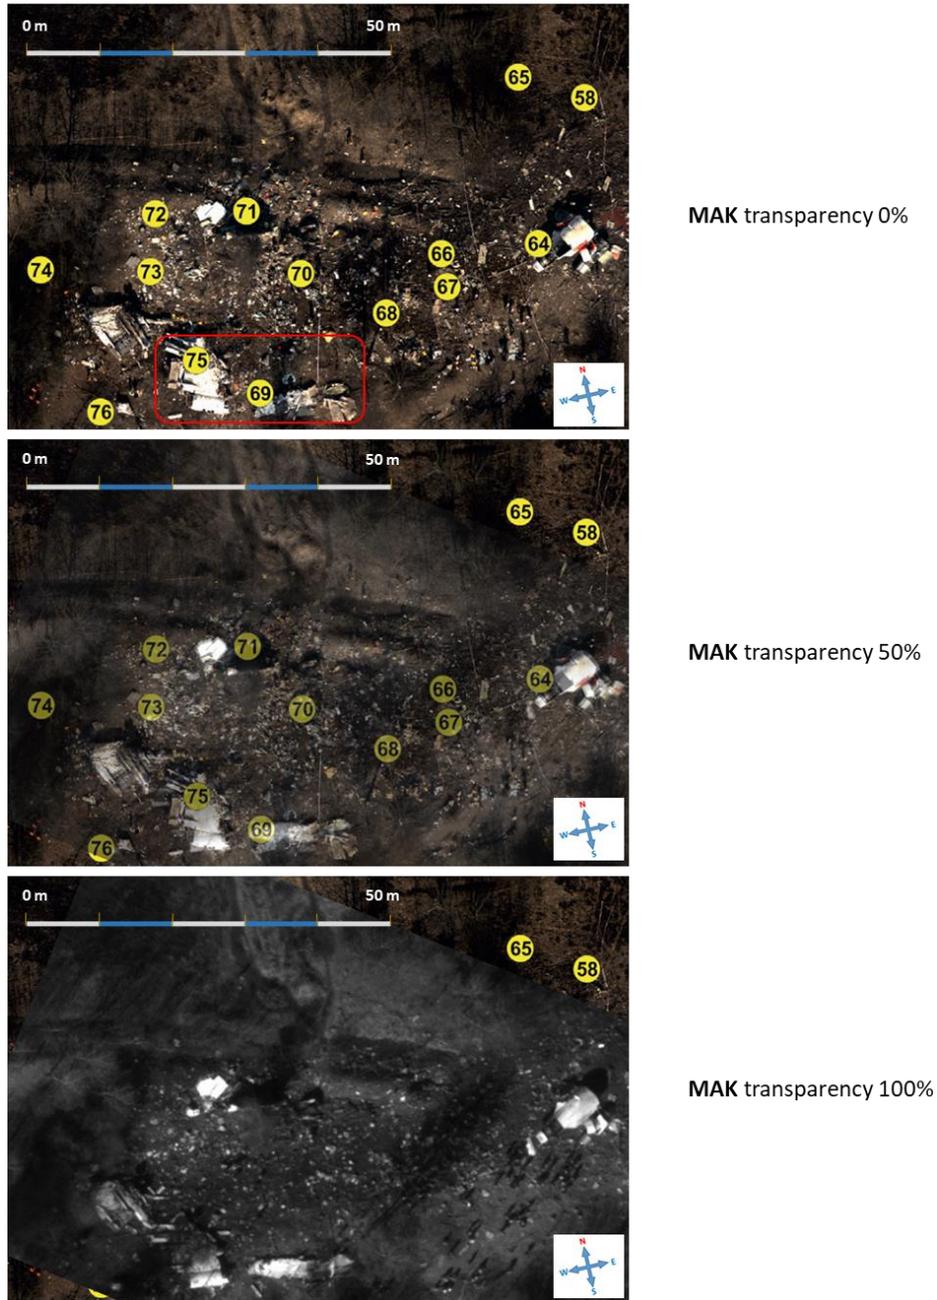
Figure 4.31 Southwest debris field images overlay. MAK [1] (color) and PSC [6] (gray scale)

Figure 4.31 overlays the South-West wreckage area the MAK image and the PSC satellite image. Orientation of the right wing fragments does not match when comparing both images. These debris seem to be rotated from its original position presented in the satellite image (gray scale image).

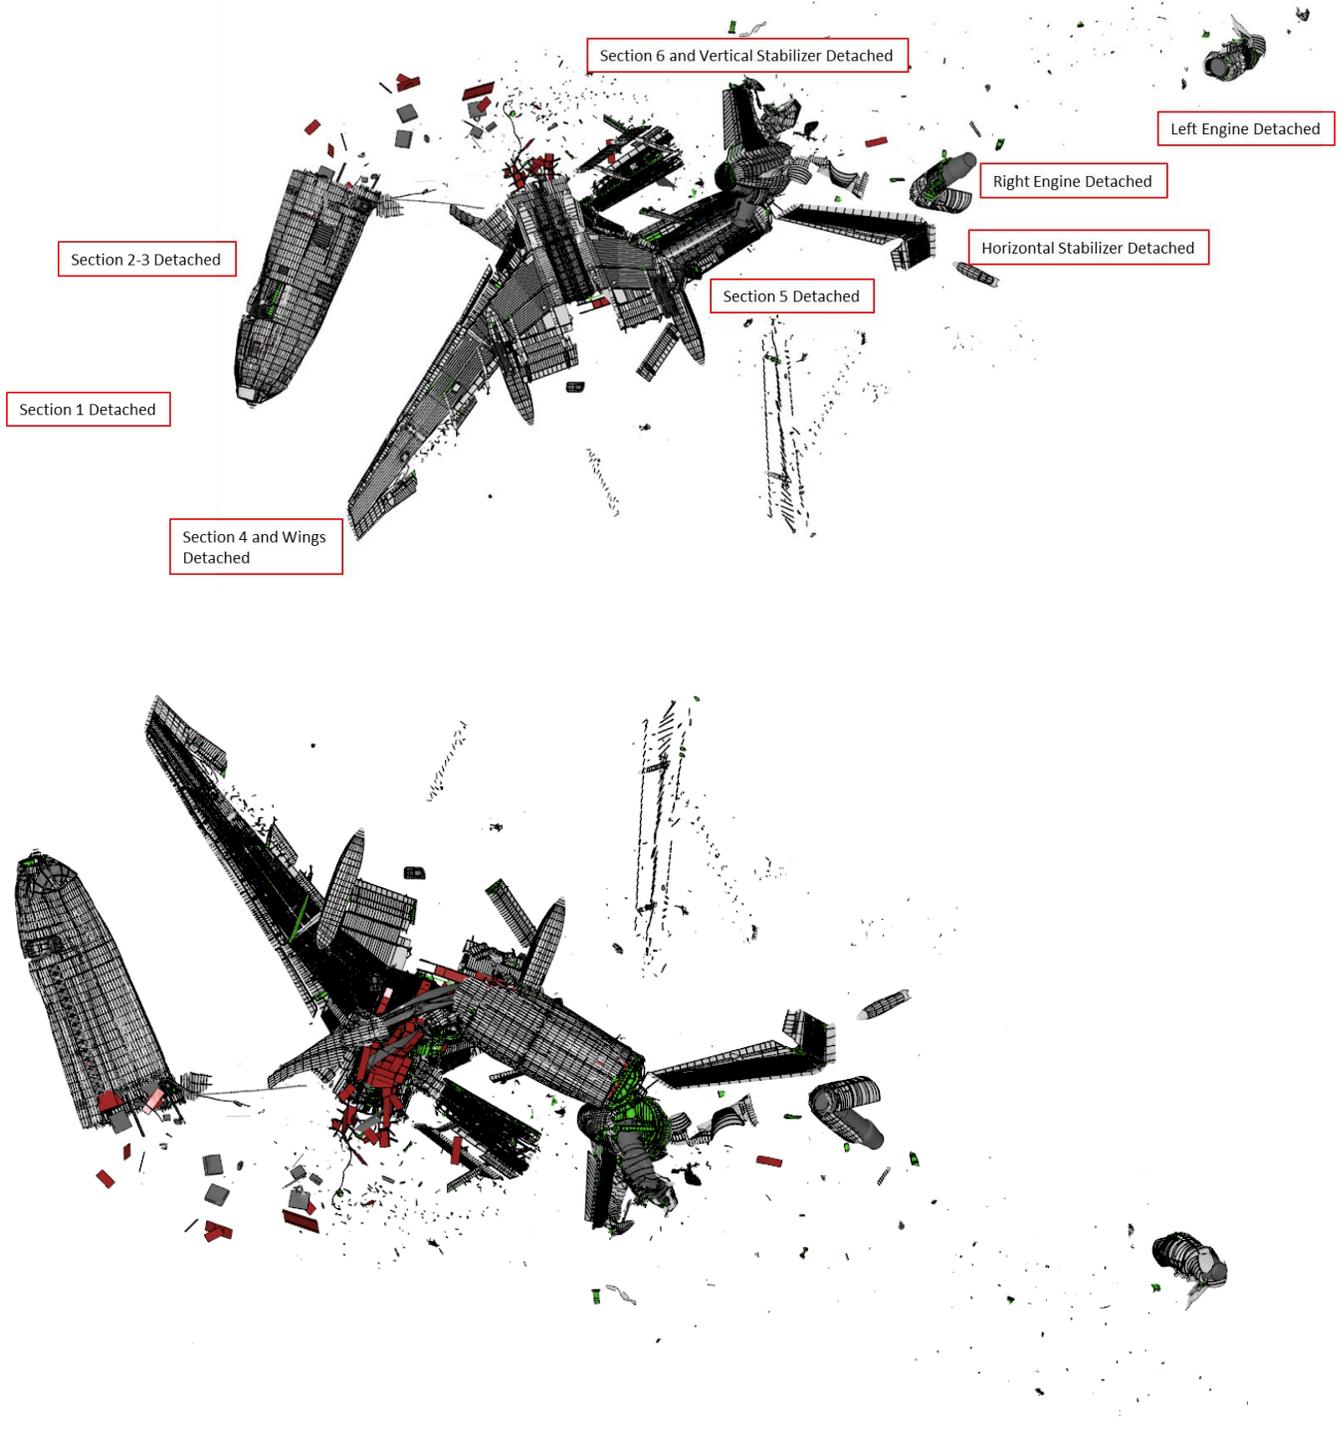
Figure 4.47 Tu154 numerical model damage at $t = 1035$ ms – Top view (top) and bottom view (bottom)

The remaining outboard portion of left wing, left horizontal stabilizer, and section 1 are the initial parts that came in contact with the ground. Due to the ground impact, the remaining outboard portion of the left wing separated from the center wing section. The left wing impact caused section 4 and the right wing to yaw clockwise (looking from directly above the aircraft and ground), while the ground impact ripped open the ceiling of sections 3 and 4. At the same time, the inertia of the forward fuselage caused sections 1, 2, and a portion of 3 to yaw counterclockwise (looking from directly above the aircraft and ground). The vertical stabilizer impact with the ground caused section 6 to separate from section 5 and rotate against its direction of travel. The vertical stabilizer remained attached to section 6 throughout the simulation. However, the horizontal stabilizer separated from the vertical stabilizer during ground impact. Both engines also separated from section 6 as they came into contact with the ground. A sequence of these aforementioned events are presented in Figure 4.32 through Figure 4.40. An image of the overall damage in the model at time = 1035 ms, as shown in Figure 4.47.

As shown in Figure 4.47 and Figure 4.48 the aircraft fuselage breaks into four major sections, forward and aft of the wing box, and forward of the pressure bulkhead. This type of fuselage fragmentation is typical of emergency landing conditions. The fuselage tends to fracture in the areas where there is a significant change in structural stiffness (Bulkheads, and Wing Box).

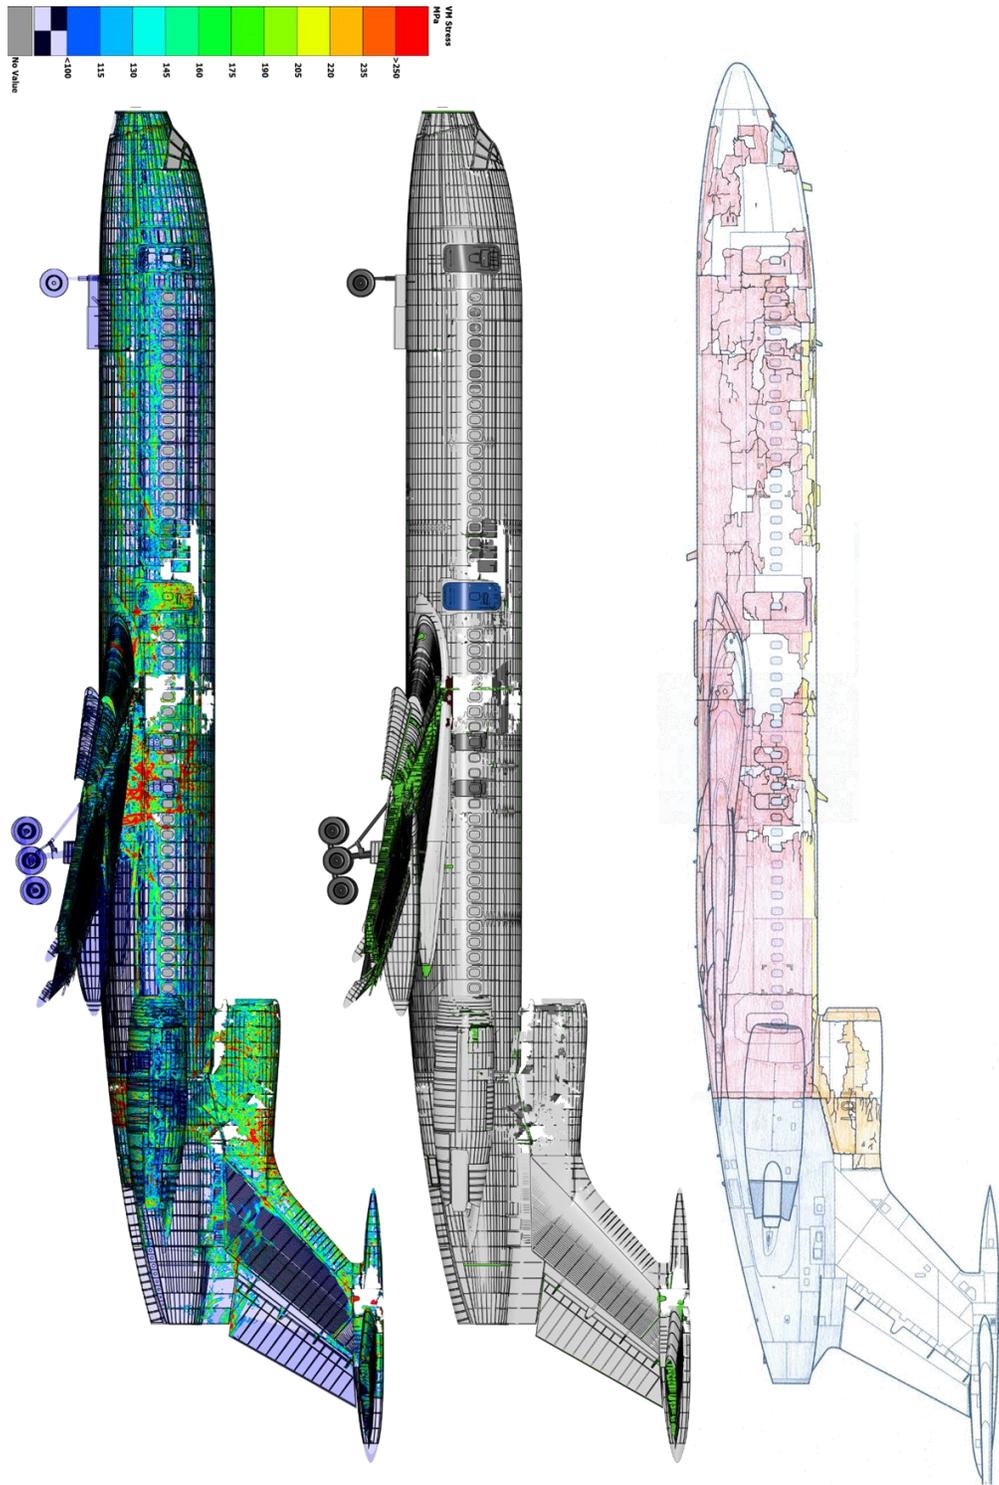
Figure 4.49 Left side Tu154 numerical model damage at $t = 1035$ ms – Comparison with PSC debris sketch [25]

A comparison with the fragmentation sketches provided by the PSC [25] is provided in Figure 4.49 and Figure 4.50. Large opening in the middle sections (Sections 3, 4 and 5) of the fuselage are noticeable in both the numerical model and the debris sketch. However, the forward fuselage sections (Sections 1 and 2) do not have less level of fragmentation compared to the debris sketches (this differences in damage on section 1 and 2 are due to the lack of information regarding the tree location, type, and size in the accident site). Significant stress concentration bend lines in areas of section 5 and the vertical stabilizers are observed in Figure 4.49 through Figure 4.53. It is important to note that, for this accident reconstruction analysis, trees were not modeled in the impact site, since data pertaining their location, size, type, etc. was not available. The contact with these trees and shrubs could result in a different kinematic path and damage of the structure (specially for Section 1 and 2) after the initial 385 ms of the accident reconstruction (Between 0 to 385 ms the accident site was free of large trees). The entire survivable volume was compromised during the first 385 ms which resulted in fatal injuries to the aircraft occupants. More details on the crash kinematics can be found in the videos contained in the final presentation package submitted with this report.

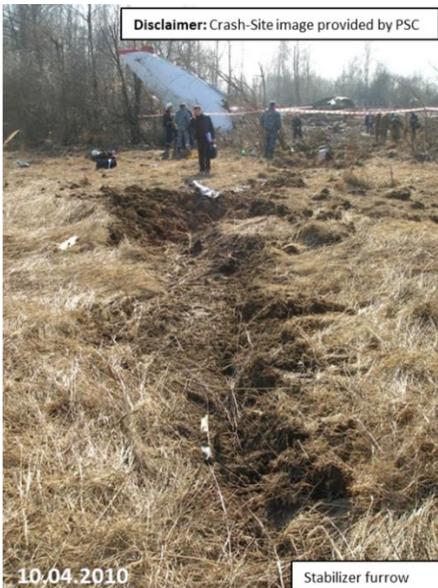
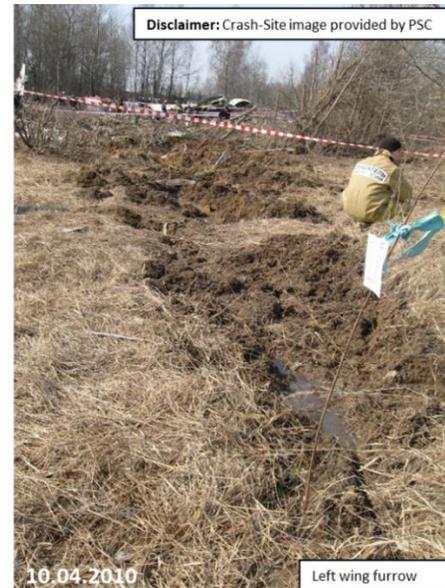
Figure 4.54 Stabilizer (left) and left wing (right) furrows in the accident site

The MAK report states “initial ground impact has a furrow made by the stabilizer and fin leading edges up to with fragments of the SI-2U light of the SMI-2KM lighting set as 0.5 m deep and 22 m long as well as a furrow made by the left wing up to 0.4 m deep and 22 m long with fragments of the left wing panel and rod N 154.83.5711-090-009” [1]. An image of the accident site furrows is shown in Figure 4.54.

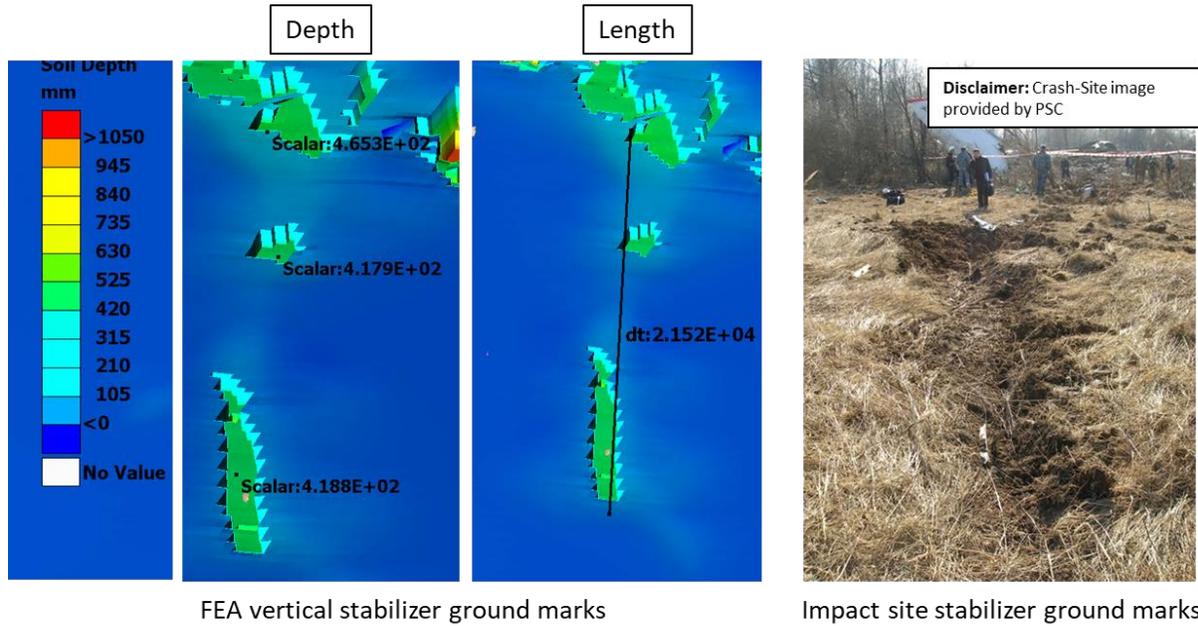
Figure 4.56 Comparison of the stabilizer furrow in the numerical model and the accident site

The numerical analysis produced a stabilizer furrow approximately 21.5 m long and 0.46 m deep, as shown in Figure 4.56. On the other hand, the left wing furrow in the numerical analysis is approximately 23.1 m long and 1.03 m deep, as shown in Figure 4.57. The ground marks measurements are tabulated in Table 4.5. It is important to highlight that these values are dependent on mesh density of the soil elements. The soil in the numerical model was modeled with 0.2 m x 0.2 m x 0.33 m solid elements due to computational efficiency constraints. Therefore, the resolution of the measured furrow depth will vary if a different element density is used in the soil model.

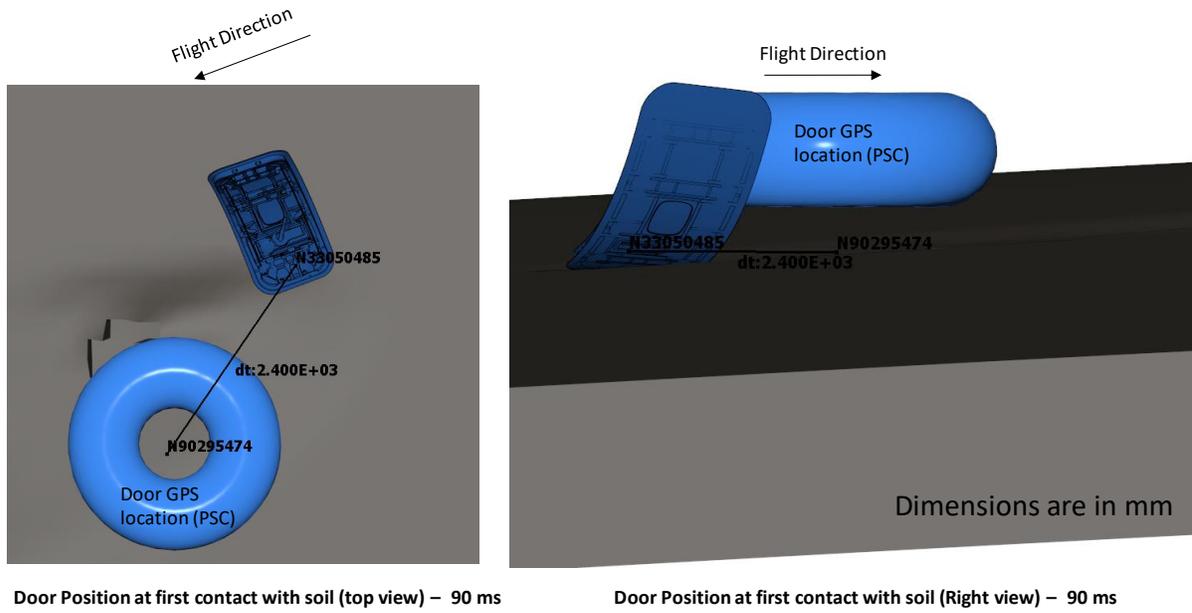
Figure 4.62 Section 3 (Simulation Time: 90 ms) – Door 823 initial impact versus door debris GPS location

The initial impact of the door 823 with the soil and the respective door 823 location in the debris field are highlighted in Figure 4.62. The door impacts about 2.4 m away from the actual location. In the simulation, door 823 separates from the fuselage within 180 ms due to ground impact and as shown in Figure 4.63. The location of the door at various times during the simulation is shown in the door kinematics presented in Figure 4.64. At 180 ms, the door is 4.3 m away from the actual location in debris field. Although the door is released at this point, the door does not get embedded into the soil due to large soil elements (0.2 m by 0.2 m by 0.33 m) as shown in Figure 4.65. The damage of the door at 180 ms is compared to the door 823 from debris field in Figure 4.65. The simulation model shows similar damage to the door around the door window area.

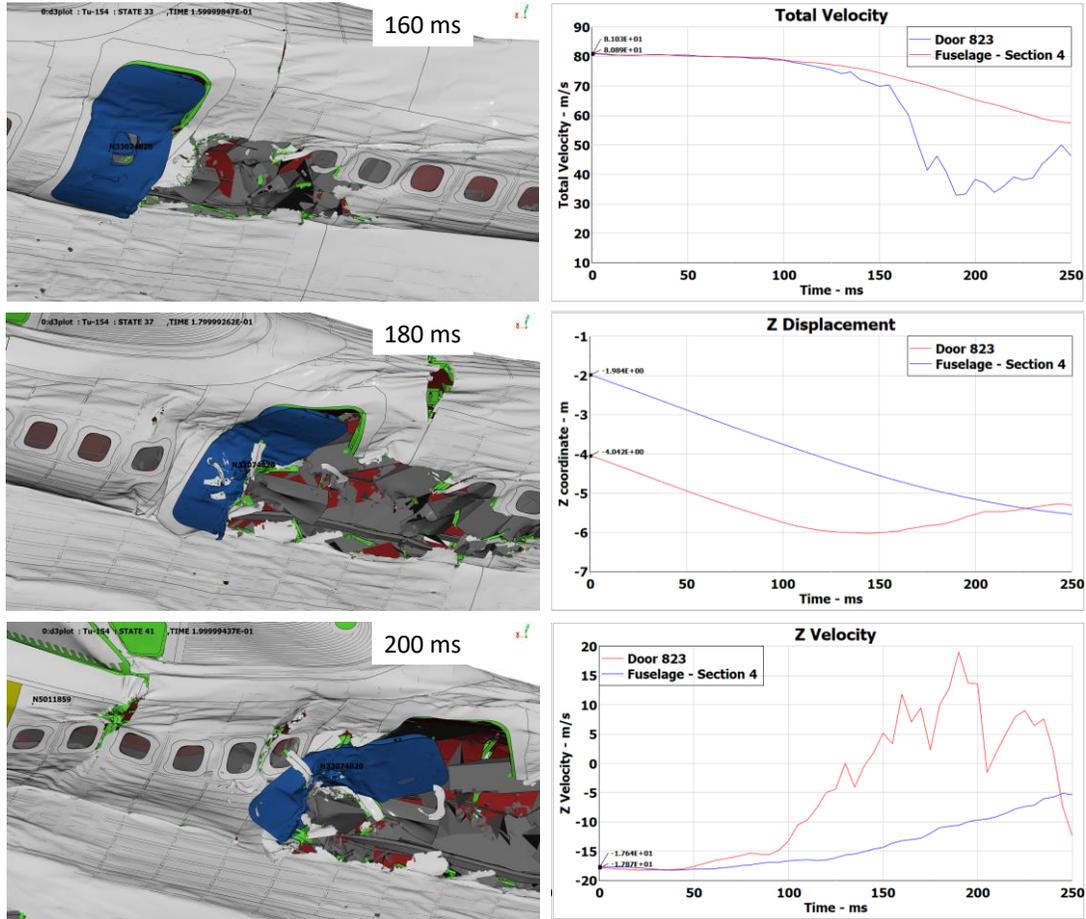
Figure 4.66 Section 3 door 823 kinematics (time: 160 – 200 ms) and total velocity and Z displacement and velocity of door 823 and fuselage section 4

Further analysis on door 823 is presented in Figure 4.66. The kinematics and total velocity plot on Figure 4.66 indicates that when the door impacts the ground its total velocity drops from 70 m/s to 31 m/s (from 160ms to 180ms). In the same time frame, the fuselage velocity drops from 75 m/s to 66 m/s. As a result, the fuselage would ride over the door exerting inertial loads on the door. In order to estimate the load exerted on the door the following is considered:

- The mass of the remaining aircraft (excluding section 1,2 and 3) – 61,574 Kg
- Change in Z velocity of the aircraft (from 180 to 200 ms based on Figure 4.66) – 1 m/s
- Estimated change in kinetic energy ($1/2 * m * v^2$) – 30,787 J
- The distance travelled by fuselage (from 180 to 200 ms based on Figure 4.66) – 0.1 m
- Force estimate ($F = E/d$) – 307,870 N – 69,209 lbs

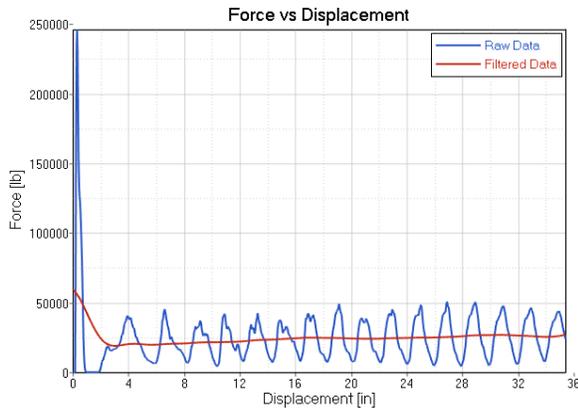
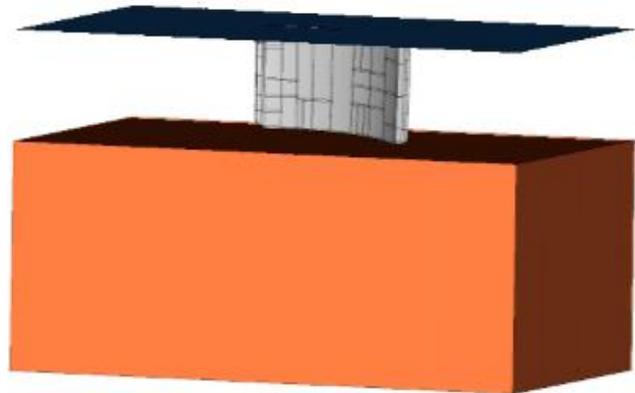
Figure 4.67 Case C1 – pushing door into soil [30]

Based on the analysis performed in the door study [30] and shown in Figure 4.67, it required an average of 25,000 lbs to push the door into the soil once the soil was penetrated. From the analysis performed, the estimated force exerted by the aircraft is 69,209 lbs which exceeds the 25,000 lbs required. This indicates that it could be possible for the door to be driven into the ground due to the inertia loads and the interior cabinets transmitting high forces. A very detailed soil model would be required to have a more detailed analysis; however, the simulation shows that it is feasible for the door 823 to be embedded in the soil.

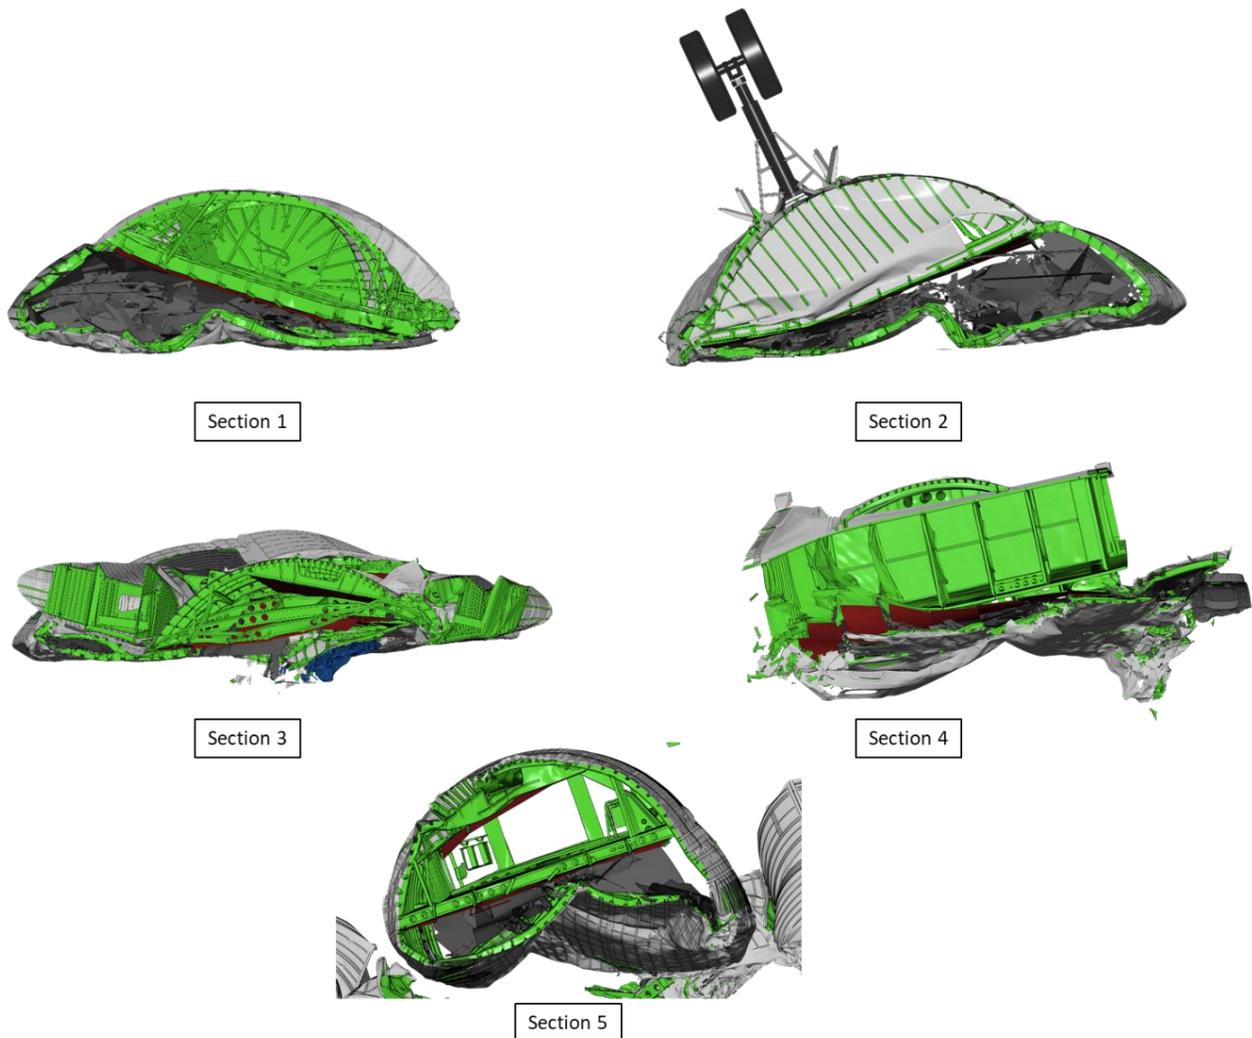
Figure 4.68 Aircraft sections survivable volume cross sections at 300 ms

In sections 4.4.3 through 4.4.10 of the annex IV report, each aircraft section was analyzed and evaluated against the survivability criteria and debris field evaluation explained in section 4.1.1 and section 4.1.2 respectively. A summary of the findings for each section is tabulated in Table 4.6 through Table 4.10. The survivable volume for each aircraft section at 300 ms is shown in Figure 4.68

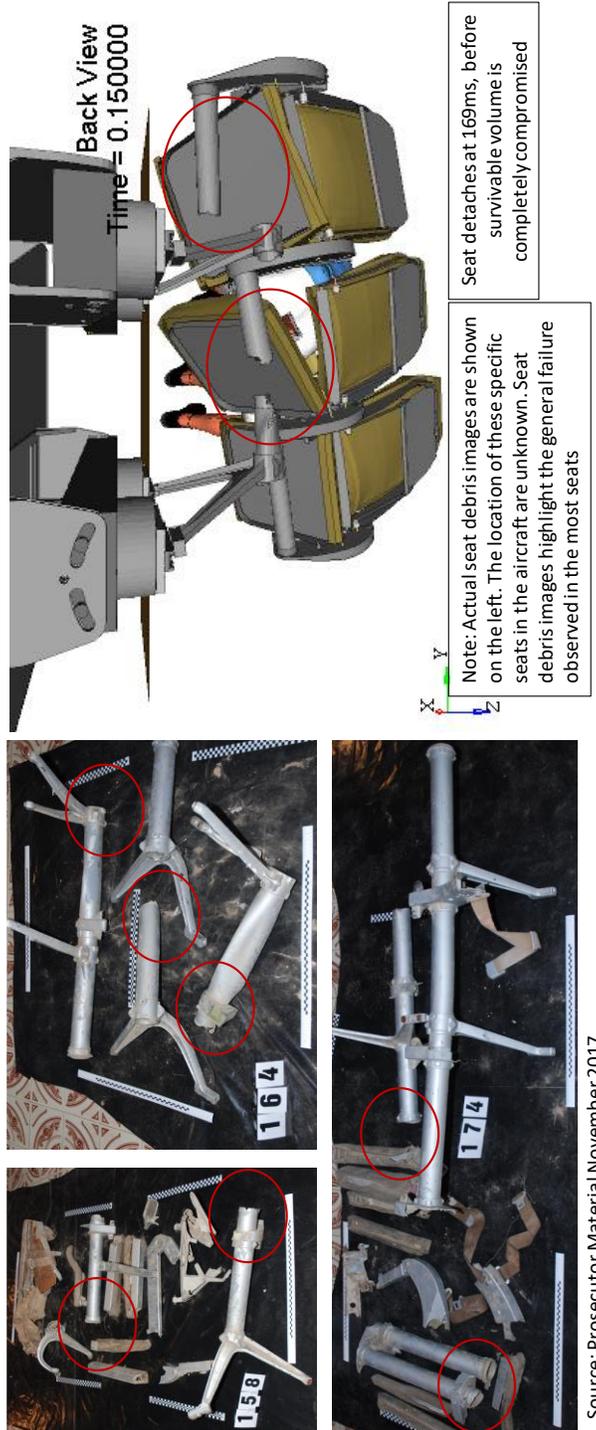
Figure 4.69 Seat analysis results with row 10 right outboard accelerations compared to various seat debris images provided by the PSC [6]

The cabin floor deceleration loads observed in the numerical model alone would result in seat and/or seat track failures before the survivable volume of each section is compromised as shown in Figure 4.69. This creates a situation in which the passengers would be able to flail inside the cabin (unrestrained), which leads to additional injuries as they come into contact with the fuselage structure, large items of mass, other occupants, and the terrain (including trees).

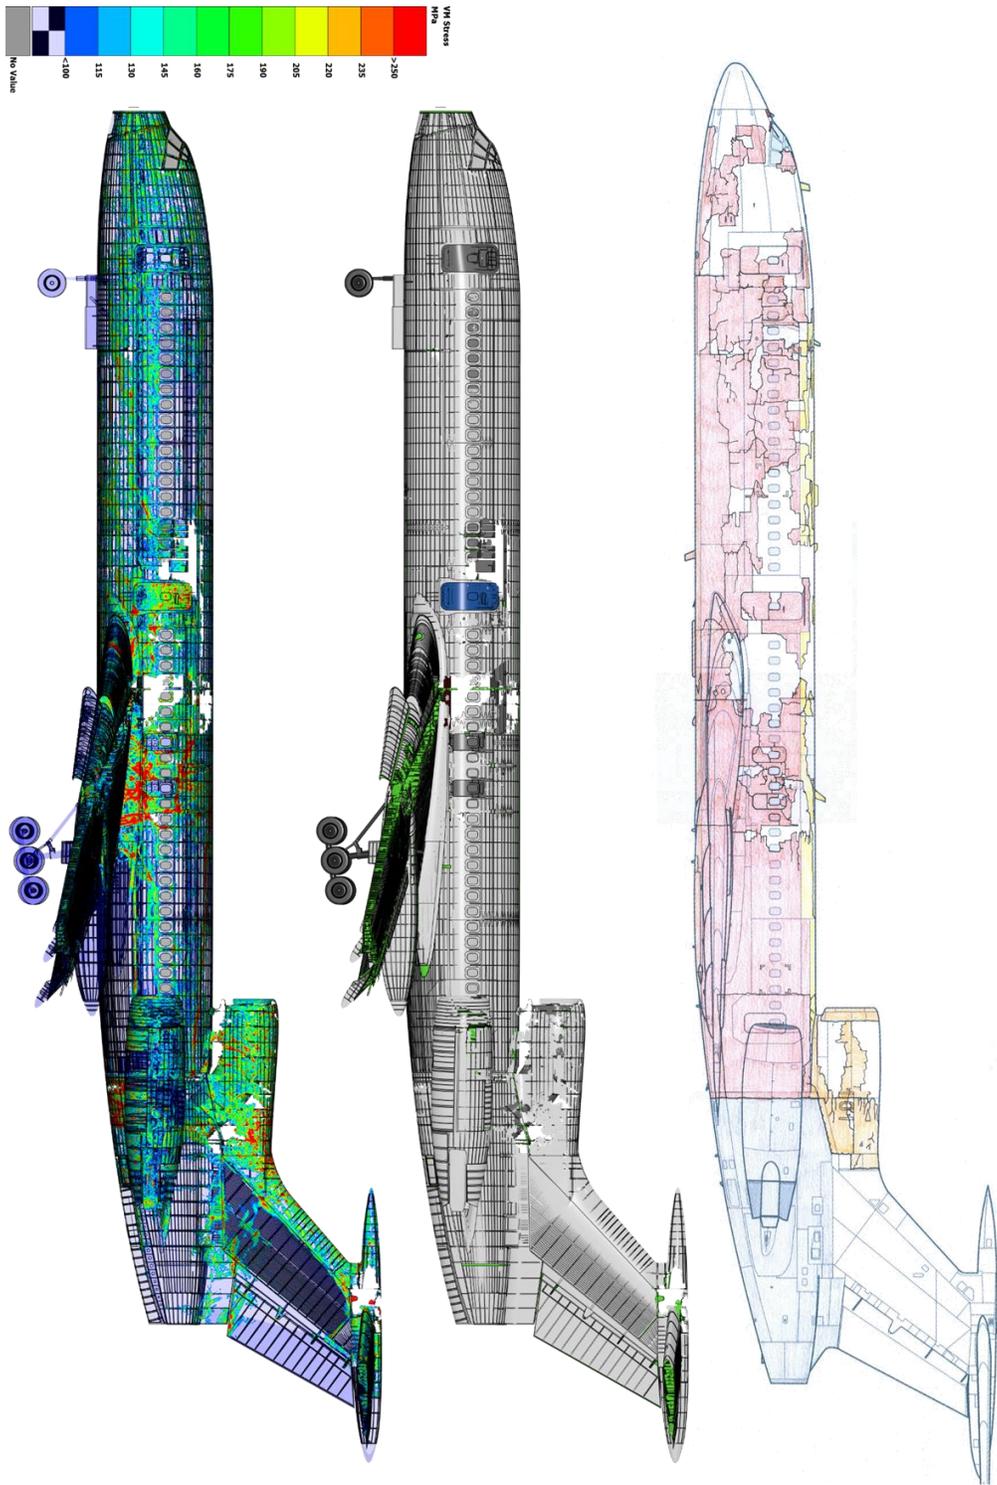
Figure 4.70 Left side Tu154 numerical model damage at $t = 1035$ ms – Comparison with PSC debris sketch [25]

- The simulation model was able to capture the length and depth of the ground marks introduced by the contact with the left wing and stabilizer.
 - The numerical model shows lesser fragmentation damage in the forward fuselage (sections 1 and 2), while it was highly fragmented in the actual accident. As alluded previously, the trees, shrubs, and other obstacles in the terrain were not modeled due to lack of information, and may introduce greater fragmentation in the numerical model (see Figure 4.70 and Figure 4.71).

- As the forward fuselage created a path for the rest of the aircraft, the rear section of the fuselage (section 5 and 6) sustained less severe fragmentation with clear defined fracture lines. There are major openings in the middle of the fuselage as shown in Figure 4.70 (Tu-154M fuselage sections 3 and 4). These openings are also present in the actual accident, albeit larger in size (see Figure 4.70 and Figure 4.71).

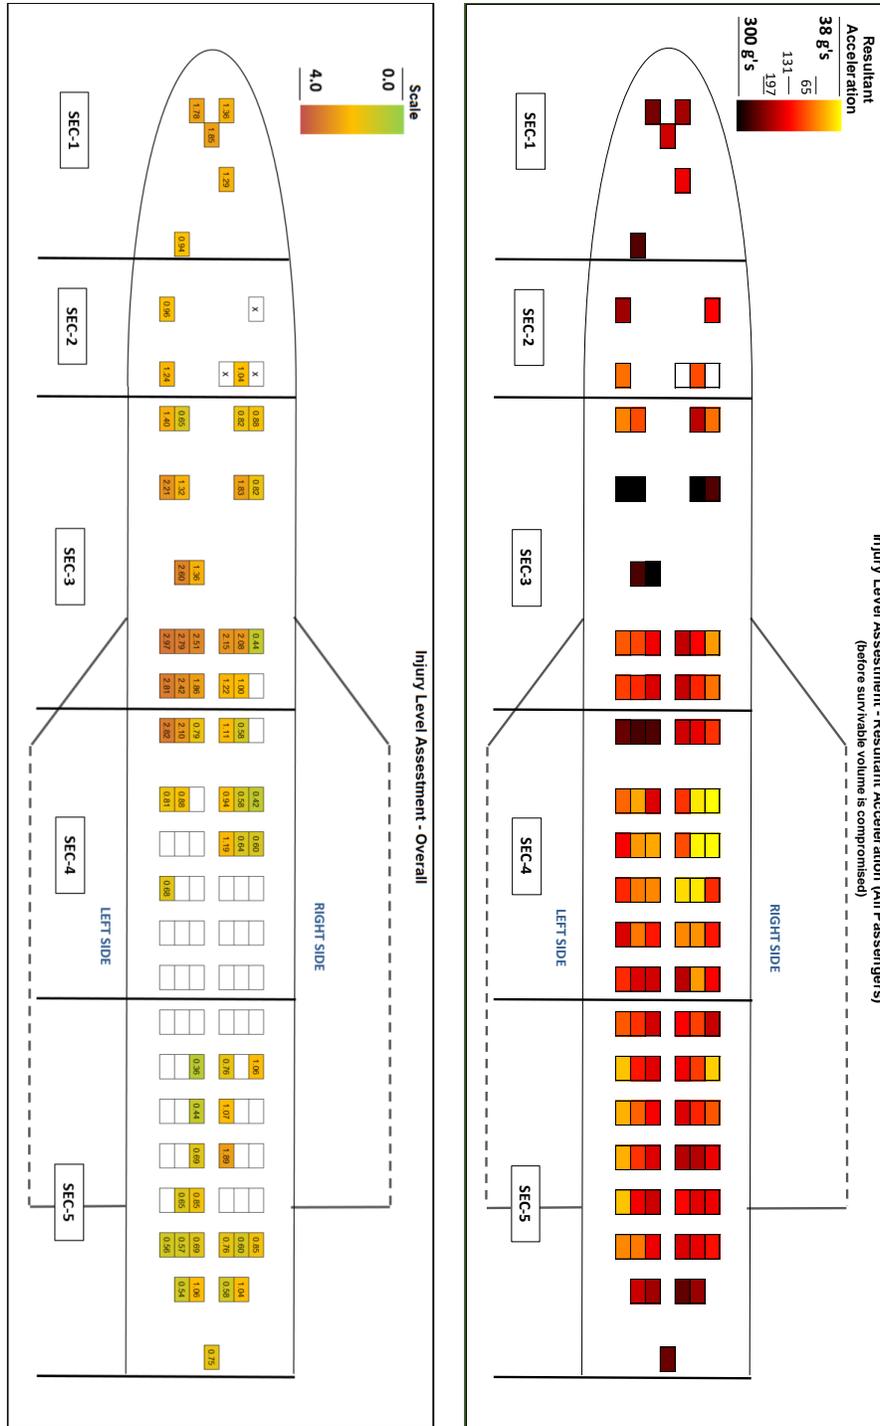
Figure 4.72 Overall passenger injury assessment [7] (left) and floor peak resultant accelerations (right)

Figure 4.72 depicts a comparison of the overall passenger injury assessments of the actual accident [7] and the fuselage cabin floor deceleration peaks observed in the numerical analysis. The forward fuselage (sections 1, 2, and 3) exhibited higher peak deceleration loads as it takes the brunt of the initial ground impact. The rear fuselage (sections 4 and 5) exhibited lower peak deceleration loads. Nonetheless, deceleration peak values (33 to 300 g's) are well beyond survivable limits. A similar pattern emerges in the injury level assessments. Passengers sitting in the forward fuselage (sections 1, 2 and 3) exhibit a greater number of severe injuries compared to those sitting in the rear fuselage (sections 4 and 5).
